Instrument Panel Assembly Replacement (C105/Short Body)

Removal Procedure

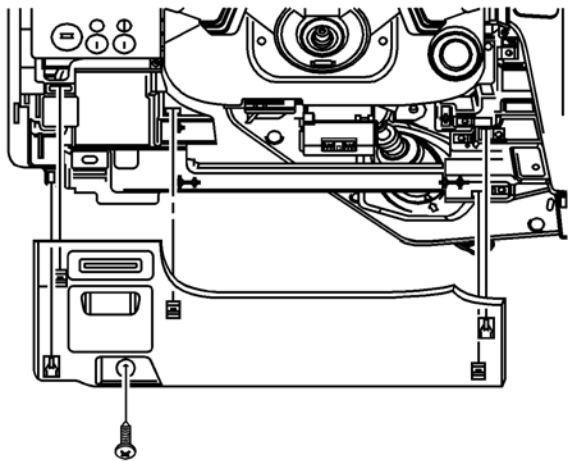
Important: Left - Hand Drive Shown, Right - Hand Drive Similar.

1. Disconnect the negative battery cable. Refer to [Battery Negative Cable Disconnection and Connection](#) .
2. Remove the instrument panel lower left trim. Refer to [Instrument Panel Lower Trim Panel Replacement - Left Side](#) .
3. Remove the front, rear floor console. Refer to [Console Replacement](#) .
4. Remove the radio . Refer to [Radio Replacement](#) .
5. Remove the headlamp leveling switch assembly. Refer to [Headlamp Leveling Switch Replacement](#) .
6. Remove the instrument cluster trim panel.
7. Remove the automatic temperature controls assembly. Refer to [Heater and Air Conditioning Control Replacement](#) .

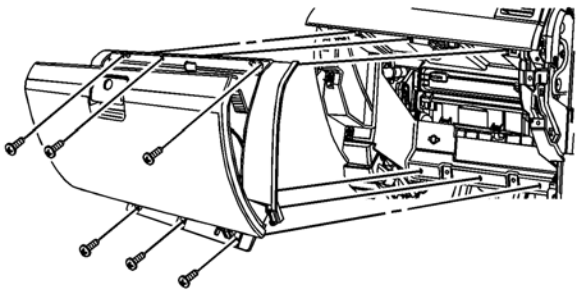
8. Remove the instrument cluster. Refer to [Instrument Cluster Replacement](#) .
9. Remove the kick panels.
10. Remove the storage compartment. Refer to [Instrument Panel Storage Compartment Replacement](#) .
11. Disconnect the instrument compartment electrical connectors.
12. Remove the knee bolster. Refer to [Knee Bolster Replacement](#) .

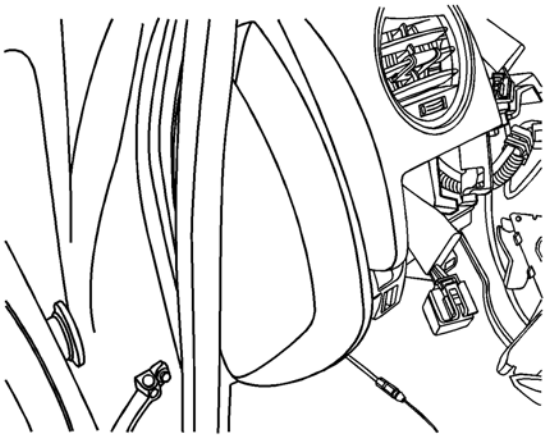
13. Remove the instrument panel side covers.
