Rear Bumper Fascia Replacement (C 105/Short Body)

Removal Procedure

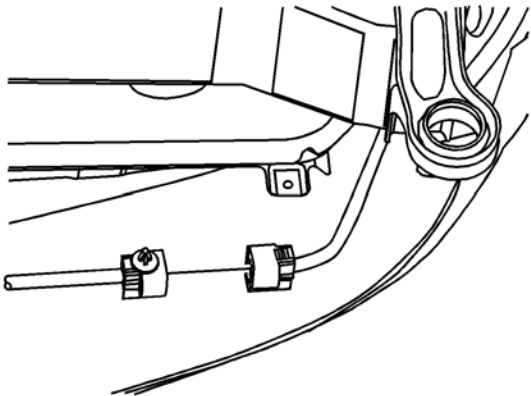
1. Disconnect the negative battery cable. Refer to [Battery Negative Cable Disconnection and Connection](#) .
2. Disconnect the connector of the rear object sensor, if equipped.

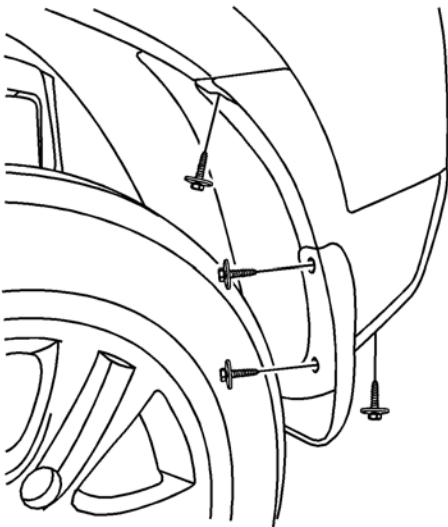
3. Remove the bolts on the rear wheelhouse liner.
