# Rear Bumper Fascia Replacement (C 100/Long Body)

## Removal Procedure

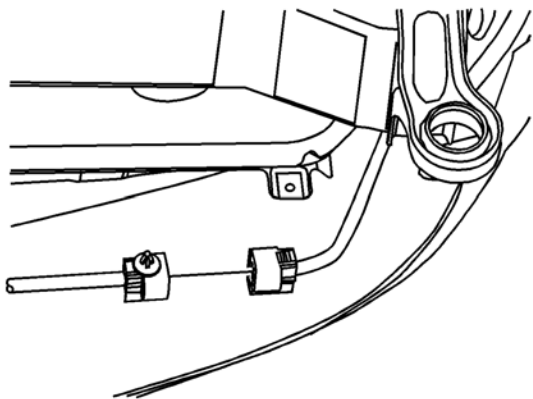
1. Disconnect the negative battery cable. Refer to [Battery Negative Cable Disconnection and Connection](#) .
2. Disconnect the connector of the rear object sensor, if equipped.

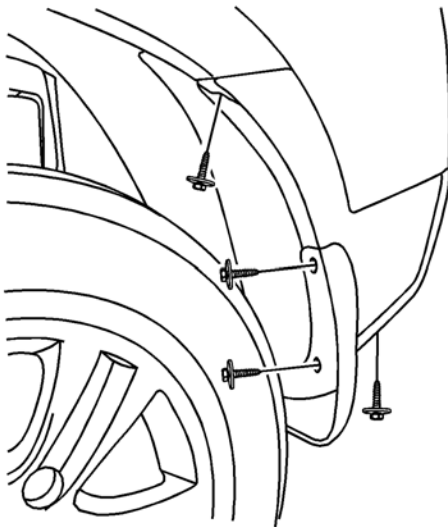
3. Remove the bolts on the rear wheelhouse liner.

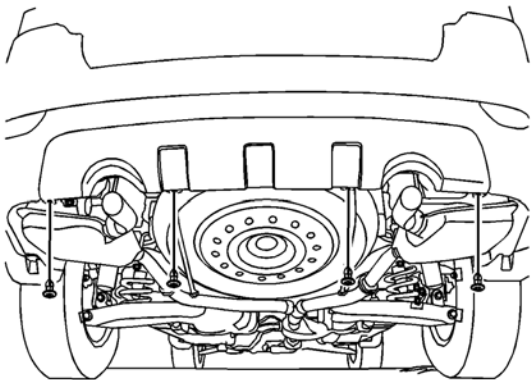
4. Remove the rear lower fascia retainers.
5. Remove the fascia.
