Instrument Panel Assembly Replacement (C100/Long Body)

Removal Procedure

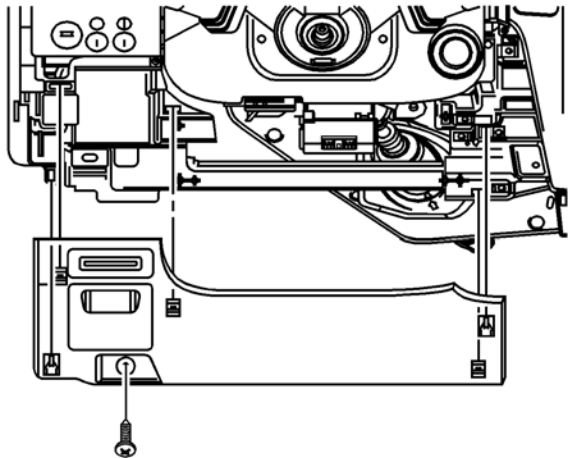
1. Disconnect the negative battery cable. Refer to [Battery Negative Cable Disconnection and Connection](#) .
2. Remove the instrument panel lower left trim. Refer to [Instrument Panel Lower Trim Panel Replacement - Left Side](#) .

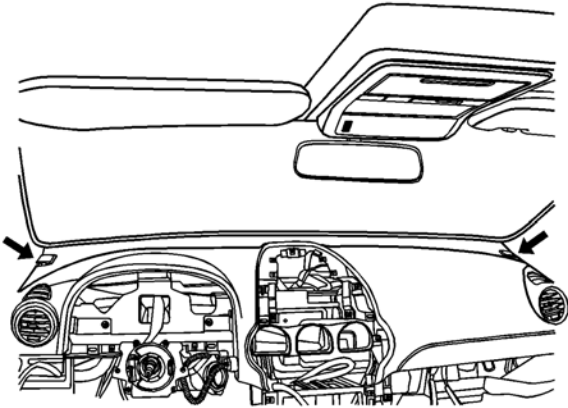
13. Remove the left and right upper instrument panel bolt covers.
14. Remove the body control module. Refer to [Body Control Module Replacement](#) .
