## Underbody Rear Side Rail Extension Replacement

### Removal Procedure

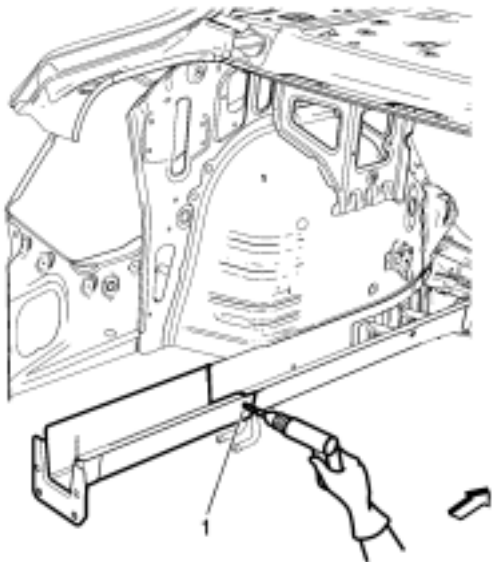
7. Drill all factory welds (1). Note the number and location of welds for installation of the service assembly.

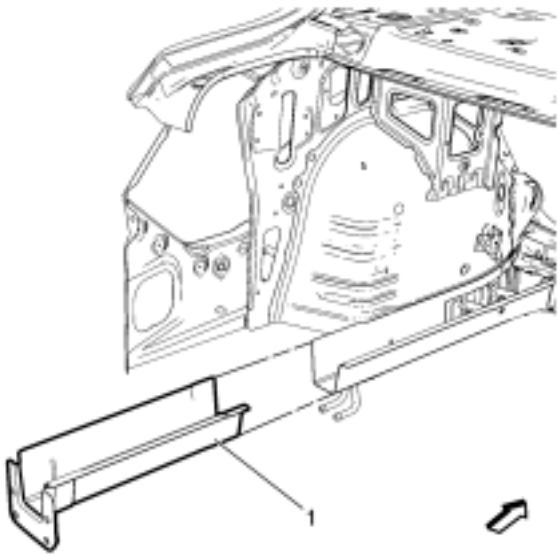
8. Remove the damaged rear side rail extension (1).
