Steering Column Replacement (N40)

Removal Procedure

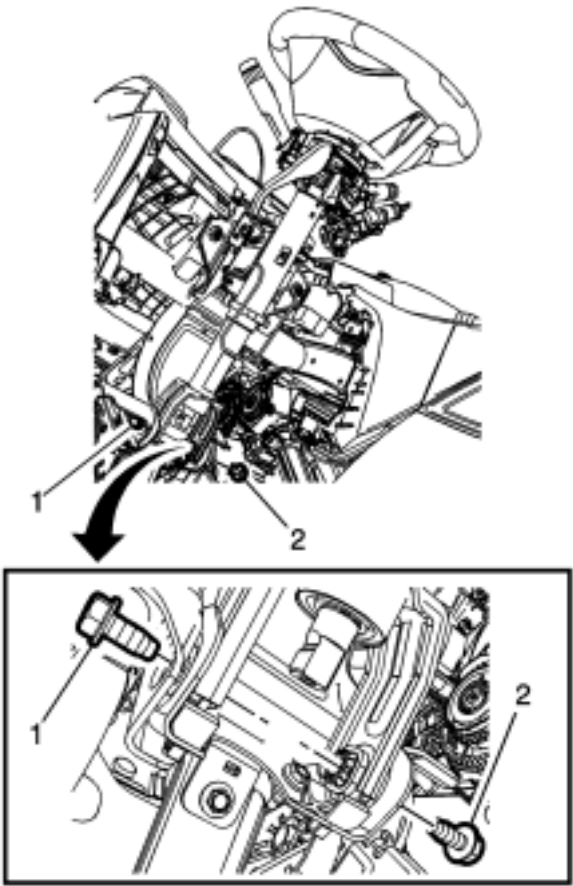
9. Remove the 2steering column lower support bracket bolts (1, 2).

8. Support the steering column.
