## Body Hinge Pillar Lower Reinforcement Replacement (MIG-Brazing)

### Removal Procedure

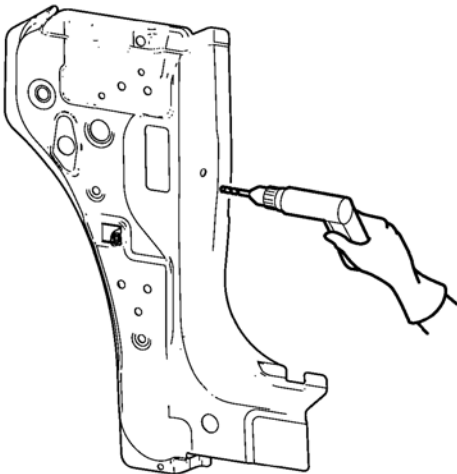
1. Prepare all mating surfaces as necessary.
2. Align the front hinge pillar body reinforcement.
