Center Pillar Sectioning

Removal Procedure

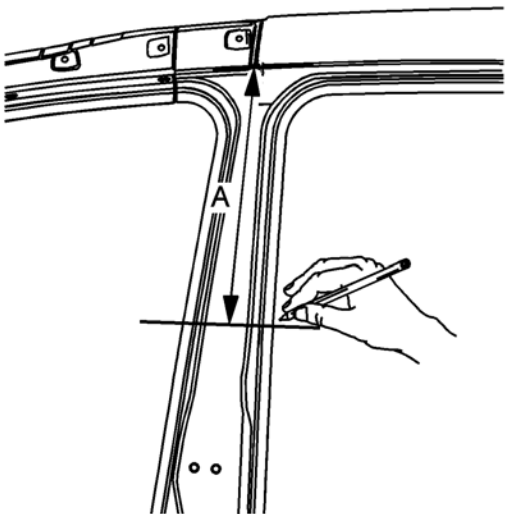
6. On the original outer door frame, measure down from the lower edge of the door opening 135 mm (5.3 in) (A) and mark a horizontal line.

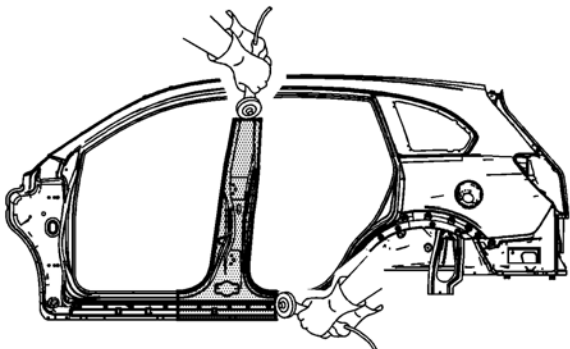
Important: Do NOT damage any inner panels or reinforcements.

7. Cut the panel where sectioning is to be performed.
