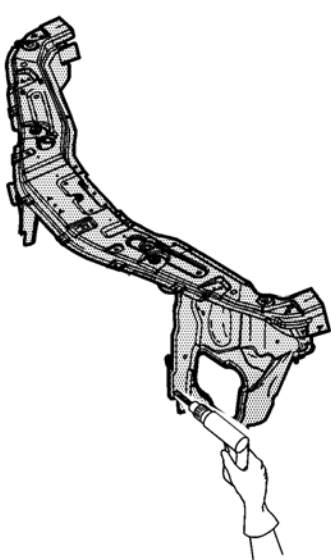
Important: If the location of the original plug weld holes can not be determined, space the plug weld holes every 40 mm (1 1/2 in) apart.

Some panels may have structural weld-thru adhesive. It is necessary to replace the weld-thru adhesive with an additional spot weld between each factory spot weld.
