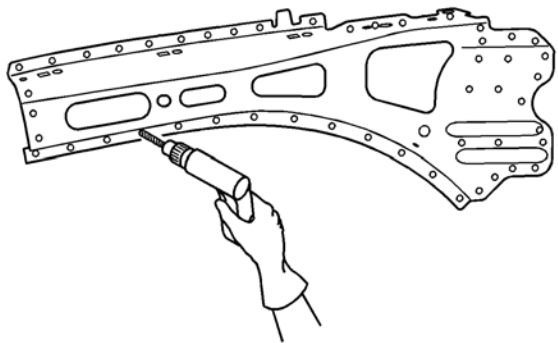
Important: If the location of the original plug weld holes can not be determined, space the plug weld holes every 40 mm (1 1/2 in) apart.

1. Drill 8-mm (5/16-in) plug weld holes in the service part as necessary in the locations noted from the original panel.
2. Prepare all mating surfaces as necessary.
3. Apply 3M Weld-Thru Coating P/N 05916 or equivalent to all mating surfaces.

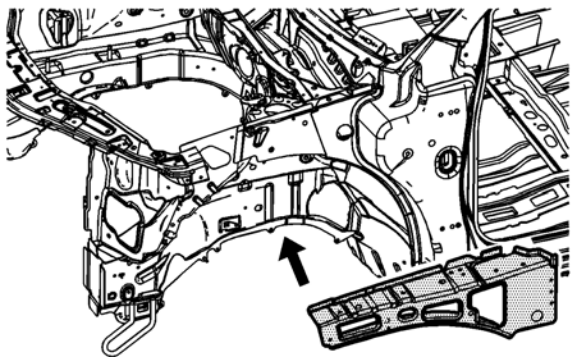
4. Position the front upper outer rail to the vehicle using 3-dimensional measuring equipment. Clamp the front upper outer rail into place.

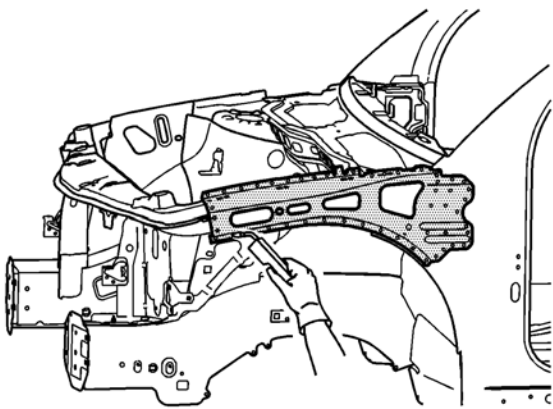
5. Plug weld accordingly.
6. Clean and prepare all welded surfaces.
7. Apply the sealers and anti-corrosion materials to the repair area, as necessary. Refer to [Anti-Corrosion Treatment and Repair](#) .
8. Paint the repair area. Refer to [Basecoat/Clearcoat Paint Systems](#) .
9. Install all related panels and components.
10. Connect the negative battery cable. Refer to [Battery Negative Cable Disconnection and Connection](#) .
11. Enable the SIR system. Refer to [SIR Disabling and Enabling](#) .
