Front Wheelhouse Front Panel Replacement

Removal Procedure

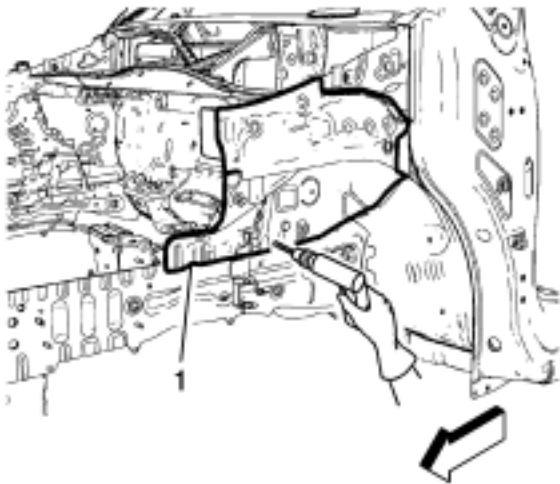
5. Locate, mark, and drill out all factory welds(1). Note the number and location of welds for installation of the service assembly.
6. Remove the front wheelhouse from the vehicle.

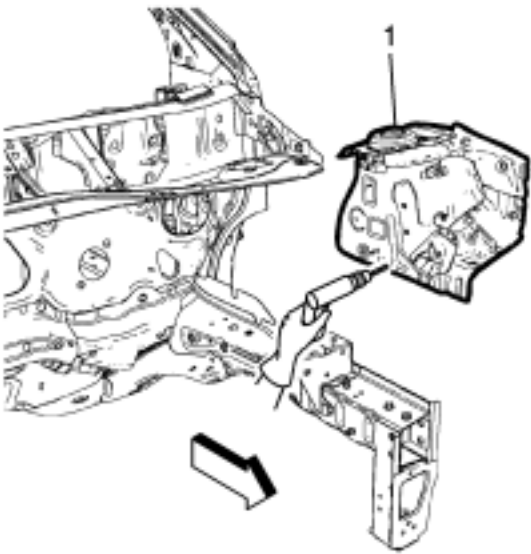
Note: If the location of the original plug weld holes cannot be determined, or if structural weld-thru adhesive is present, space the plug weld holes every **40mm (1 in)**.

1. Drill **8mm (5/16 in)** plug weld holes as necessary on service part, in the locations noted from the original assembly(1).
2. Clean and prepare the mating surfaces for welding, as necessary.
3. Apply GM-approved weld-thru coating or equivalent to all mating surfaces. Refer to [Anti-Corrosion Treatment and Repair](#) .
