## Tail Lamp Pocket Replacement (5HB)

### Removal Procedure

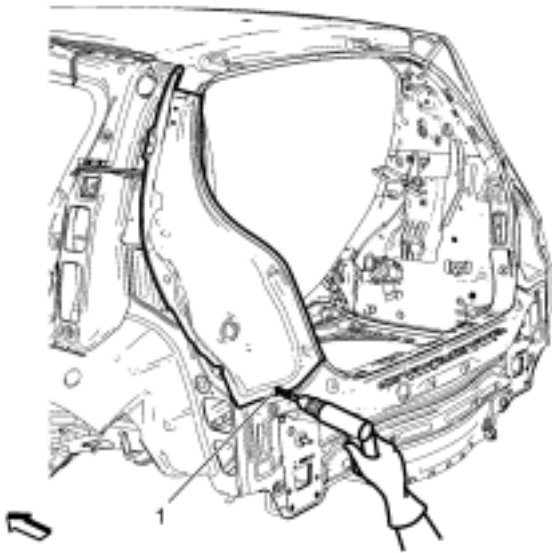
7. Drill all factory welds (1). Note the number and location of welds for installation of the service assembly.

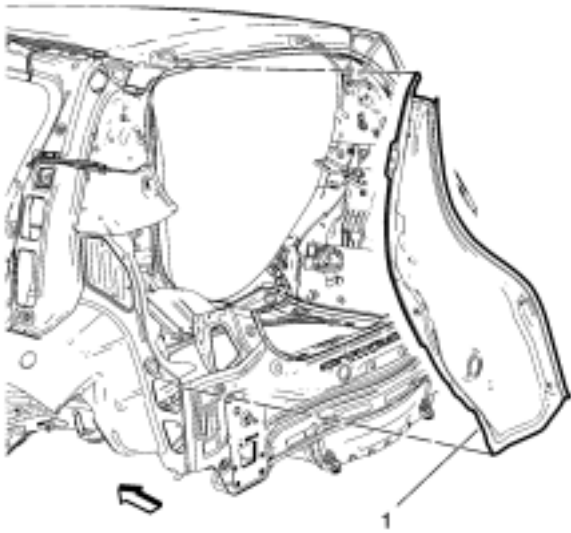
8. Remove the tail lamp pocket (1).
