Front End Upper Tie Bar Replacement (MAG-Welding)

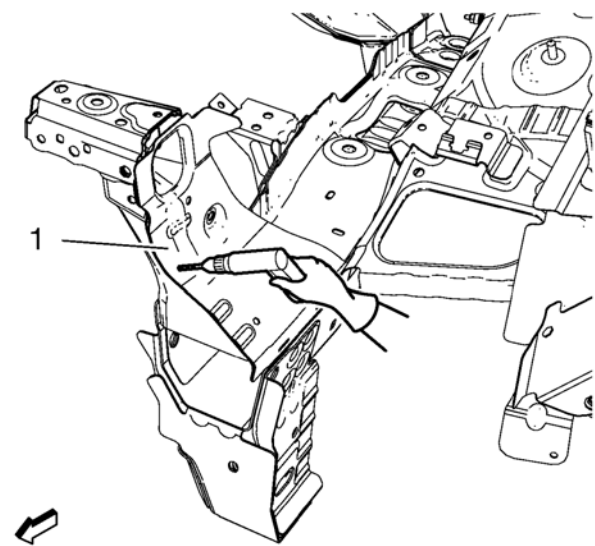
6. Locate and mark all the necessary factory welds of the front end sheet metal cross panel reinforcement (1).
7. Drill all factory welds. Note the number and location of welds for installation of the service assembly.

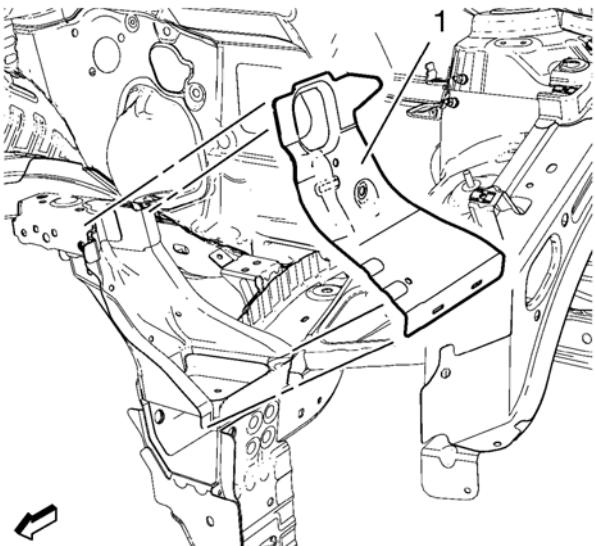
8. Remove the front end sheet metal cross panel reinforcement (1).
9. Drill all factory welds.

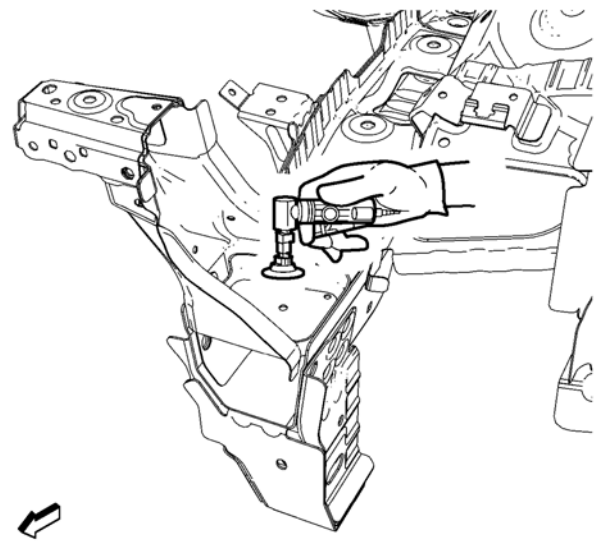
10. Grind factory welds of the front end upper tie bar.
