## Underbody Rear Side Rail Reinforcement Replacement (MIG-Brazing)

**Note:** According to different corrosion warranties, only the regional mandatory joining methods are allowed.

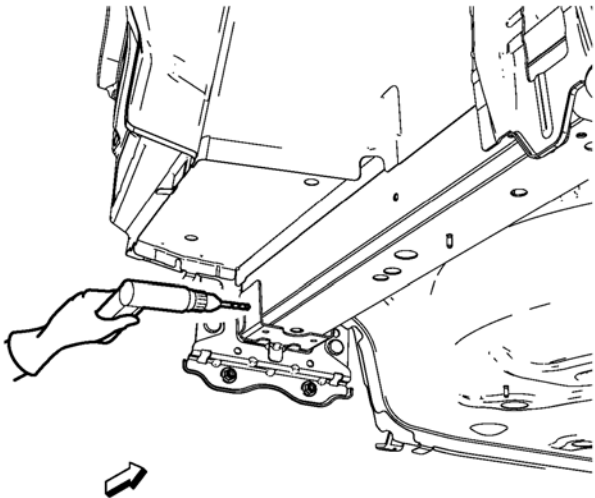
6. Locate and mark all the necessary factory welds of the rear end panel plate.

**Note:** Note the number and location of welds for installation of the service assembly.

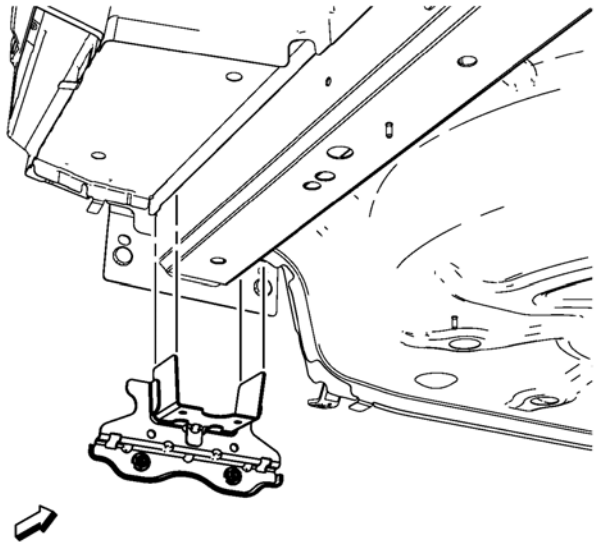
7. Drill all factory welds.

8. Remove the underbody rear side rail reinforcement.

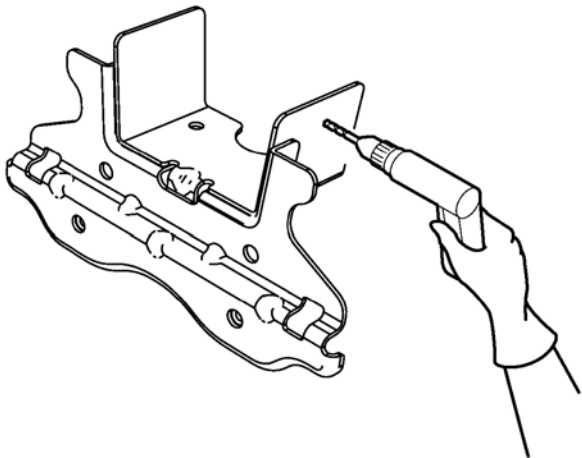
1. Create 8 24 mm (5/16 x 15/16 in) slots for MIG-brazing along the edges of the underbody rear side rail reinforcement as noted from
