2005-06 ACURA RL

COMPONENT LOCATION GRAPHICS

NOTE: Figures may show multiple component locations. Refer to appropriate table for proper figure references.

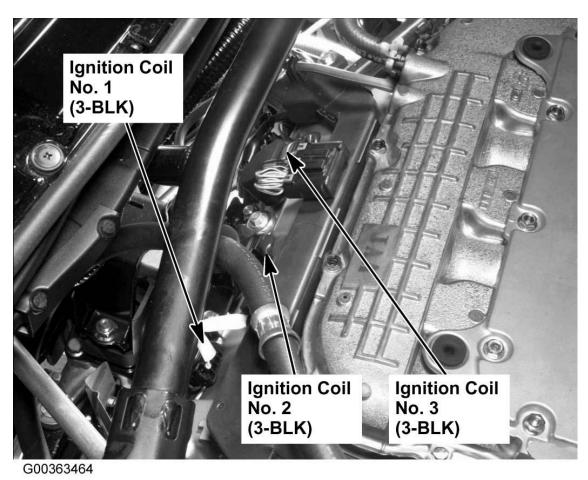
Fig. 10: Middle Of Engine Courtesy of AMERICAN HONDA MOTOR CO., INC.

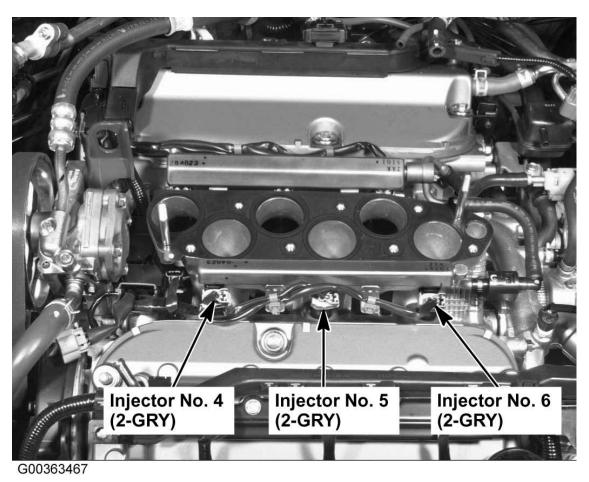
Fig. 13: Middle Of Engine Courtesy of AMERICAN HONDA MOTOR CO., INC.

IMT Valve	Right side of engine. See Fig. 8 .
Injector No. 1	Middle of engine. See Fig. 12.
Injector No. 2	Middle of engine. See Fig. 12.
Injector No. 3	Middle of engine. See Fig. 12.
Injector No. 4	Middle of engine. See Fig. 13

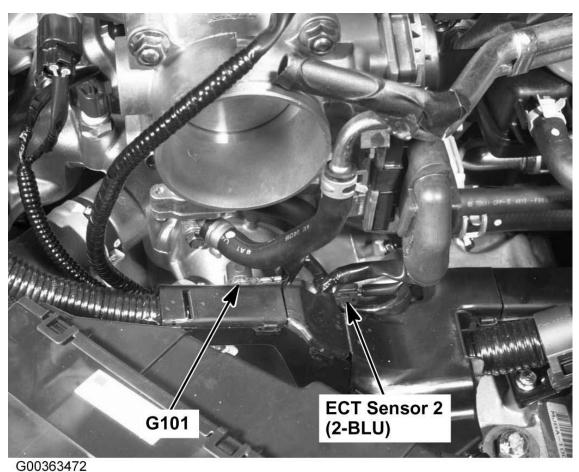
Fig. 17: Left Side Of Engine Courtesy of AMERICAN HONDA MOTOR CO., INC.

MAP Sensor	Left side of engine. See Fig. 17 .
Output Shaft (Countershaft) Speed Sensor	In transmission housing. See Fig. 182.
Outside Air Temperature Sensor	Behind middle of front bumper. See Fig. 172.
Rear A/F Sensor (B1, S1) Connector	Middle of engine. See Fig. 9 .
Rear Safing Sensor	Under rear seat. See Fig. 124 .
Rear Secondary HO2S (B1, S2) Connector	Middle of engine. See Fig. 9 .
Right Front Impact Sensor	Behind right side of front bumper. See Fig. 173 .
Right Front Pressure Sensor	Left side of engine compartment. See Fig. 197 .
Right Front Wheel Speed Sensor Connector	On right side of engine compartment. See Fig. 1 .
Right Rear Wheel Speed Sensor Connector	Under right rear of vehicle. See Fig. 184.
Right Side Impact Sensor	At base of right "B" pillar. See Fig. 125 .
Right Side Impact Sensor (2nd)	In right "C" pillar. See Fig. 147 .
Seat Weight Sensor Unit	Under front passenger's seat. See Fig. 115 .

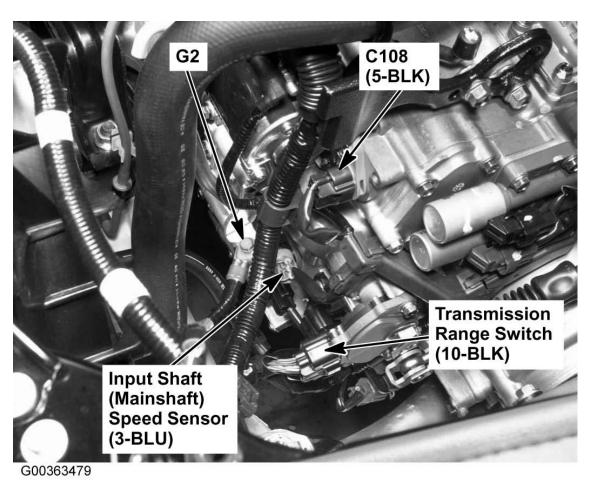
Fig. 24: Transmission Housing Courtesy of AMERICAN HONDA MOTOR CO., INC.

Component	Location
A/C Compressor Connector	Right side of engine compartment. See Fig. 178.
A/T Clutch Pressure Control Solenoid Valve A	On transmission housing. See Fig. 24.
A/T Clutch Pressure Control Solenoid Valve B	On transmission housing. See Fig. 24
A/T Clutch Pressure Control Solenoid Valve C	On transmission housing. See Fig. 26
Driver's Seat Belt Tension Reducer Solenoid Connector	On base of left "B" pillar. See Fig. 125.
ECPS Valve Connector	Left side of engine compartment. See Fig. 22 .
EGR Valve	Left side of engine. See Fig. 20 .
Engine Mount Control Solenoid Valve	Middle of engine. See Fig. 21.
EVAP Canister Purge Valve	At left side of engine compartment, near strut tower. See Fig. 17 .
EVAP Canister Vent Shut Valve	Under rear of vehicle. See Fig. 70 .
Front Passenger's Seat Belt Tension Reducer Solenoid Connector	On base of right "B" pillar. See Fig. 125.
Fuel Fill Door Opener Solenoid	On left side of trunk. See Fig. 156 .

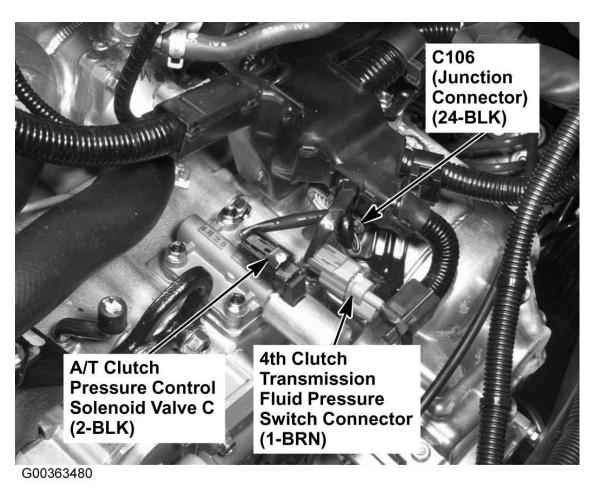
Fig. 25: Transmission Housing Courtesy of AMERICAN HONDA MOTOR CO., INC.

Component	Location
G1	Left side of engine compartment. See Fig. 30 .
G2	Top of transmission housing. See Fig. 25 .
G3	Right side of engine compartment. See Fig. 3 .
G4	Right side of engine compartment. See <u>Fig. 3</u> .
G101	Left side of engine. See Fig. 18.
G102	On right front of engine. See Fig. 7.
G201	Behind right side of front bumper. See Fig. 170 .
G202	Right side of engine compartment. See Fig. 6 .
G301	Behind left side of front bumper. See Fig. 174.
G351	Middle of engine compartment. See Fig. 179.
G401	Under right side of dash. See Fig. 91 .
G501	Under left side of dash. See Fig. 53.
G502	Under left side of dash. See Fig. 53.
G503	Under middle of dash. See Fig. 77 .
G504	Under middle of dash. See Fig. 79.
G505	Under center console. See <u>Fig. 85</u> .
G506	Behind glove box. See Fig. 90 .
G601	At left side of floor. See Fig. 121 .
G602	In left "C" pillar. See <u>Fig. 147</u> .
G603	In left "C" pillar. See <u>Fig. 148</u> .

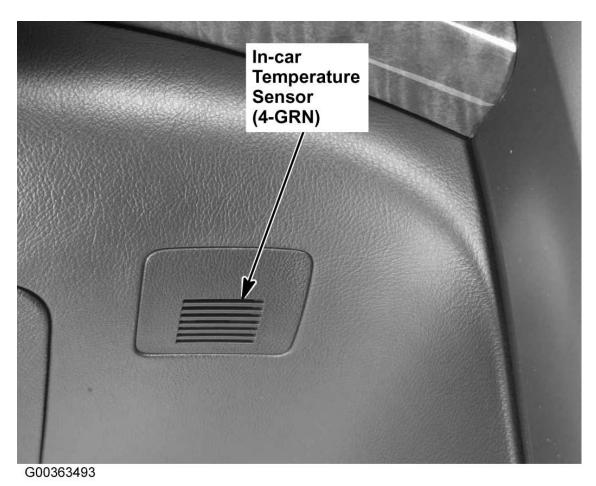
Fig. 38: Under Left Side Of Cowl Cover Courtesy of AMERICAN HONDA MOTOR CO., INC.

Fuel Tank Unit	Under rear seat. See Fig. 122 .
Left Power Mirror Connector	In driver's door. See Fig. 129 .
Left Rear Power Window Motor	Center of left rear door. See Fig. 137 .
Left/Right Adaptive Front Lighting Gear Box	Behind respective headlight assembly. See Fig. 27 .
Left/Right Headlight Leveling Motor	Behind respective headlight assembly. See <u>Fig.</u> <u>28</u> .
Mode Control Motor	Under left side of dash. See Fig. 67.
Rear Vent Control Motor	Under middle of dash. See Fig. 83.
Recirculation Control Motor	Behind glove box. See Fig. 92 .
Right Rear Power Window Motor	Center of right rear door. See Fig. 137.
Starter	Left side of engine. See Fig. 23.
Windshield Washer Motor	In bottom of washer reservoir. See Fig. 169 .
Windshield Wiper Motor	Left rear of engine compartment, under cowl cover. See Fig. 38 .

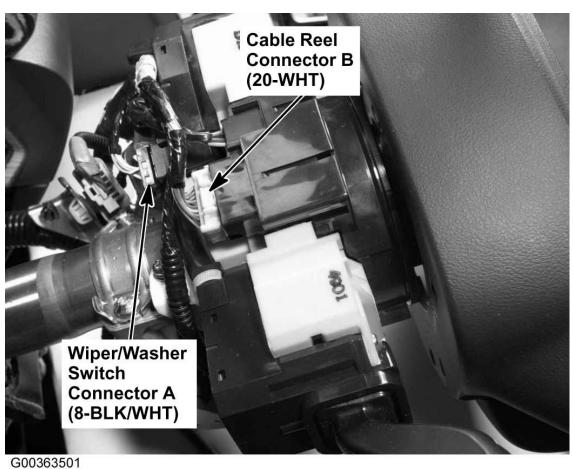
Fig. 46: In Steering Wheel Cover Courtesy of AMERICAN HONDA MOTOR CO., INC.

Secondary Fuel Gauge Sending Unit	Under rear seat. See <u>Fig. 123</u> .
Steering Angle Sensor	On side of steering column. See Fig. 46.
Telescopic Motor/Position Sensor Connector	Under steering column cover. See Fig. 50 .
Tilt Motor/Position Sensor Connector	Under steering column cover. See Fig. 50.
TP Sensor/Throttle Actuator	On throttle body. See Fig. 19 .
Yaw Rate-Lateral Acceleration Sensor	Under center console. See Fig. 84.

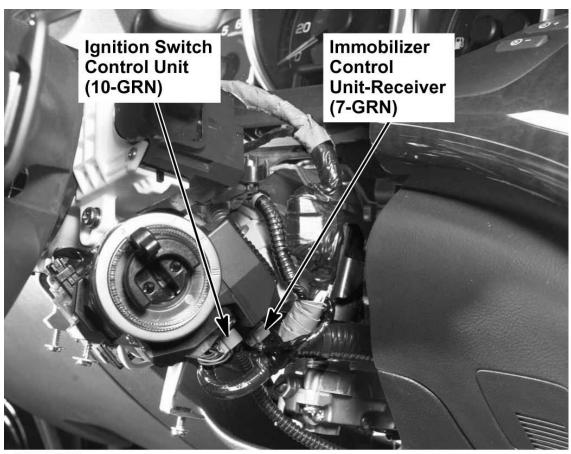
Fig. 48: In Steering Wheel Cover Courtesy of AMERICAN HONDA MOTOR CO., INC.

Junction Connector C310 (2006)	Left side of engine compartment. See <u>Fig. 35</u> .
Junction Connector C404 (2005)	Under left side of dash. See <u>Fig. 56</u> .
Junction Connector C404 (2006)	Under left side of dash. See <u>Fig. 198</u> .
Junction Connector C405	Under steering column cover. See Fig. 48 .
Junction Connector C507	Behind left side of dash. See <u>Fig. 41</u> .
Junction Connector C508	Behind left side of dash. See <u>Fig. 41</u> .
Junction Connector C509	Behind left side of dash. See <u>Fig. 41</u> .
Junction Connector C510	Behind left side of dash. See <u>Fig. 40</u> .
Junction Connector C511	Behind left side of dash. See <u>Fig. 40</u> .
Junction Connector C512	Behind left side of dash. See Fig. 40 .
Junction Connector C513	Behind left side of dash. See <u>Fig. 40</u> .
Junction Connector C514	Under left side of dash. See <u>Fig. 56</u> .
Junction Connector C515	Behind middle of dash. See <u>Fig. 73</u> .

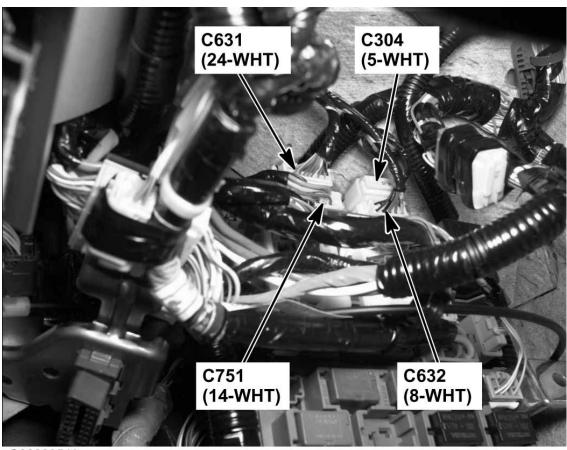
Fig. 56: Under Left Side Of Dash Courtesy of AMERICAN HONDA MOTOR CO., INC.

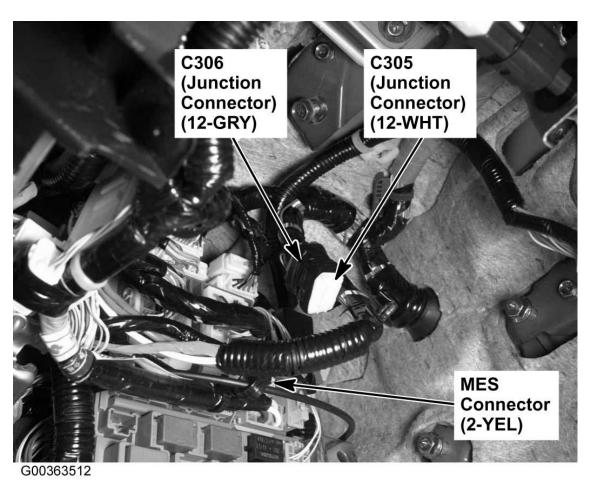
Fig. 57: Under Left Side Of Dash Courtesy of AMERICAN HONDA MOTOR CO., INC.

Component	Location
C101 (Black, 33 Pin)	Left side of engine compartment. See Fig. 36 .
C102 (Gray, 33 Pin)	Left side of engine compartment. See Fig. 36 .
C103 (Black, 23 Pin)	Left side of engine compartment. See Fig. 36 .
C104 (Gray, 1 Pin)	Left side of engine compartment, near shock tower. See Fig. 34 .
C108 (Black, 5 Pin)	Top of transmission housing. See Fig. 25 .
C151 (Black, 6 Pin)	Right side of engine. See Fig. 176 .
C152 (Black, 1 Pin)	Top middle of engine. See Fig. 14.
C201 (White, 18 Pin)	Behind right kick panel. See Fig. 99 .
C251 (White, 13 Pin)	Under right side of dash. See Fig. 93.
C301 (White, 34 Pin)	Under left side of dash. See Fig. 55.
C302 (Brown, 3 Pin)	Behind lower left side of dash. See Fig. 55.
C303 (Yellow, 4 Pin)	Behind lower left side of dash. See Fig. 55 .
C304 (White, 5 Pin)	Behind lower left side of dash. See Fig. 57 .
C308 (Gray, 2 Pin)	Left side of engine compartment. See Fig. 181 .

C402 (White, 34 Pin)	Under left side of dash. See Fig. 54.
C403 (Yellow, 4 Pin)	Under left side of dash. See Fig. 54.
C501 (White, 17 Pin)	Under middle of dash. See Fig. 81 .
C502 (White, 12 Pin)	Behind right side of dash. See Fig. 95 .
C503 (Brown, 2 Pin)	Behind right side of dash. See Fig. 95 .
C505 (USA) (Gray/White, 2 Pin)	Behind middle of dash. See Fig. 78 .
C551 (2005) (Gray, 6 Pin)	Under center console. See Fig. 87 .
C551 (2006) (Light Blue, 6 Pin)	Under center console. See Fig. 87 .
C599 (Gray, 8 Pin)	Under center console. See Fig. 86 .
C601 (White, 23 Pin)	Behind left kick panel. See Fig. 63 .
C602 (White, 20 Pin)	Behind left kick panel. See Fig. 62.
C603 (2006) (Light Blue, 6 Pin)	Behind middle of dash. See Fig. 78 .
C604 (Yellow, 16 Pin)	Behind middle of dash. See Fig. 78.
C606 (White, 24 Pin)	In left "C" pillar. See Fig. 145.
C631 (White, 24 Pin)	Under left side of dash. See Fig. 57 .
C632 (White, 8 Pin)	Under left side of dash. See Fig. 57 .

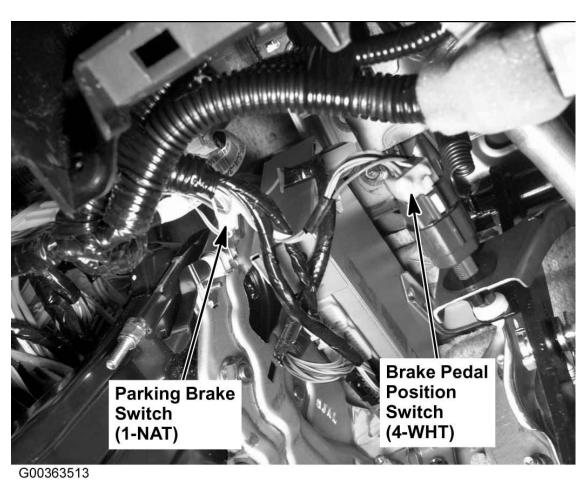
Fig. 58: Under Left Side Of Dash Courtesy of AMERICAN HONDA MOTOR CO., INC.

Front Passenger's Side Airbag Inflator Connector	Under front passenger seat. See Fig. 113.
GPS Antenna	Middle of rear shelf. See Fig. 160.
High Horn	Behind middle of front bumper. See Fig. 171 .
Ignition Coil No. 1	Middle of engine. See Fig. 10.
Ignition Coil No. 2	Middle of engine. See Fig. 10.
Ignition Coil No. 3	Middle of engine. See Fig. 10.
Ignition Coil No. 4	Middle of engine. See Fig. 15.
Ignition Coil No. 5	Middle of engine. See Fig. 15.
Ignition Coil No. 6	Middle of engine. See Fig. 15.
Junction Connector C105	Middle of engine. See Fig. 11.
Junction Connector C106	Top of transmission. See Fig. 26 .
Junction Connector C107 (2006)	Middle of engine. See Fig. 11 .
Junction Connector C202 (2006)	Behind right side of dash. See Fig. 201.
Junction Connector C203 (2006)	Right side of engine compartment. See $\underline{Fig. 2}$.
Junction Connector C305	Under left side of dash. See Fig. 58 .
Junction Connector C306	Under left side of dash. See <u>Fig. 58</u> .

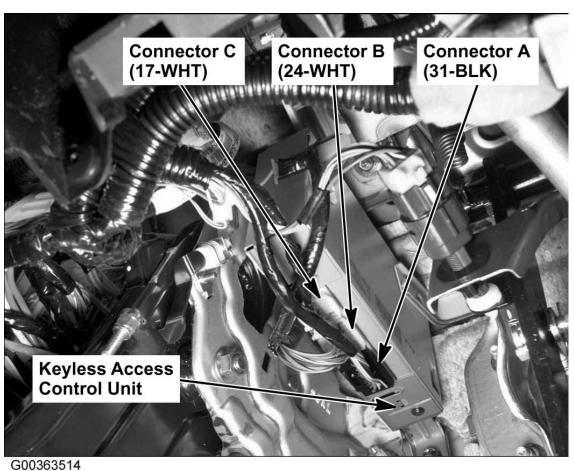
Fig. 59: Under Left Side Of Dash Courtesy of AMERICAN HONDA MOTOR CO., INC.

Component	Location
Brake Fluid Level Switch	Integral to brake fluid reservoir cap. See Fig. 37.
Brake Pedal Position Switch	Near brake pedal. See Fig. 59 .
Driver's Seat Belt Switch Connector	Under driver's seat. See Fig. 109 .
Front Passenger's Seat Belt Switch Connector	Under front passenger's seat. See Fig. 112 .
Oil Pressure Switch	Right side of engine. See Fig. 175.
Parking Brake Switch	Under left side of dash. See Fig. 59.
PSP Switch	Right side of engine. See Fig. 177 .
Security Hood Switch Connector	Behind middle of front bumper. See Fig. 171 .
Transmission Range Switch	On transaxle. See Fig. 25 .
VTEC Oil Pressure Switch	Right side of engine. See Fig. 175.
Washer Fluid Level Switch Connector	Behind right side of front bumper. See Fig. 169 .
2nd Clutch Transmission Fluid Pressure Switch	Top left side of engine. See Fig. 21 .
3rd Clutch Transmission Fluid Pressure Switch	On transmission. See Fig. 182.

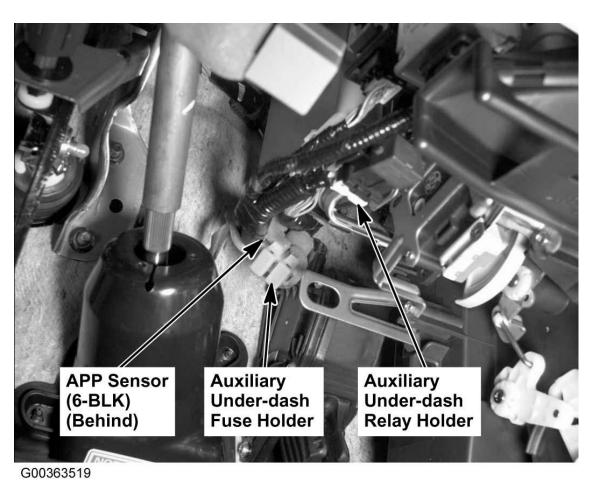
Fig. 64: Under Left Side Of Dash Courtesy of AMERICAN HONDA MOTOR CO., INC.

Component	Location
Auxiliary Under-Dash Fuse Holder	Under left side of dash. See Fig. 65 .
Auxiliary Under-Dash Relay Box	Under left side of dash. See Fig. 64.
Auxiliary Under-Dash Relay Holder	Under left side of dash. See Fig. 65 .
Auxiliary Under-Hood Relay Box	Left rear of engine compartment. See Fig. 35 .
Battery Terminal Fuse Box (+)	In battery terminal fuse box. See Fig. 33 .
Driver's Under-Dash Fuse/Relay Box	Behind left kick panel. See Fig. 61.
Passenger's Under-Dash Fuse/Relay Box	Behind right kick panel. See Fig. 97 .
Under-Hood Fuse/Relay Box	Left rear of engine compartment. See Fig. 31 .

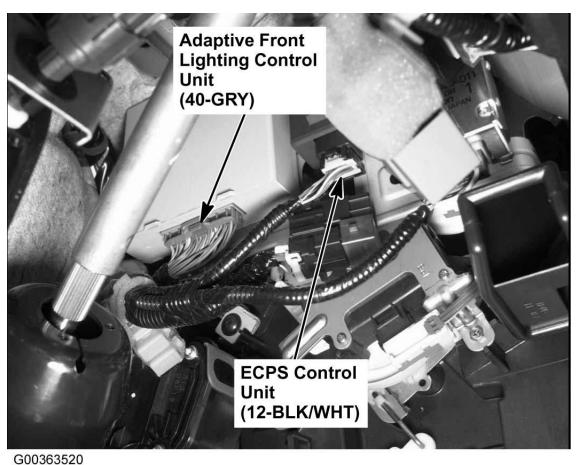
Fig. 65: Under Left Side Of Dash Courtesy of AMERICAN HONDA MOTOR CO., INC.

Component	Location
A/C Pressure Sensor	Right side of engine compartment. See Fig. 4 .
APP Sensor	Under left side of dash. See Fig. 65 .
ATF Transmission Sensor	On transmission housing. See Fig. 182.
Automatic Lighting Sensor/Sunlight Sensor	Front center of dash. See Fig. 71 .
CKP Sensor 1 & 2	Right side of engine. See Fig. 175 .
CMP Sensor	Right side of engine. See Fig. 8 .
Differential Oil Temperature Sensor Connector	On rear differential. See Fig. 189 .
Driver's Door Outer Handle Light/Touch Sensor	
Connector	Center of driver's door. See <u>Fig. 133</u> .
Driver's Power Seat Front Up-Down	Dight side of driver's seet See Fig. 102
Motor/Position Sensor Connector	Right side of driver's seat. See Fig. 102 .
Driver's Power Seat Rear Up-Down	Left side of driver's seat. See Fig. 101 .
Motor/Position Sensor Connector	Left side of driver's seat. See Fig. 101.
Driver's Power Seat Recline Motor/Position	Under driver's seat. See Fig. 103 .

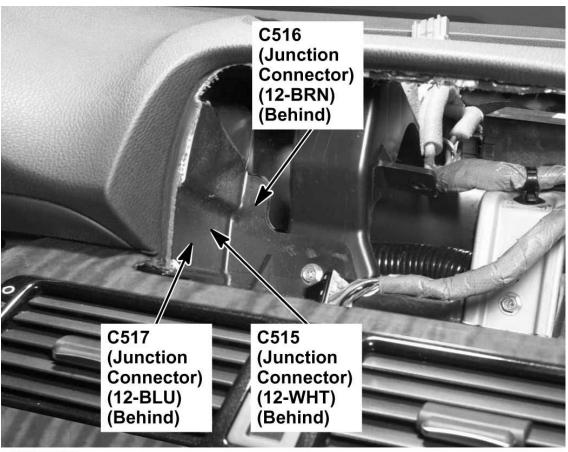
Fig. 72: Rear Of Center Console Courtesy of AMERICAN HONDA MOTOR CO., INC.

Junction Connector C852	In left front of roof. See Fig. 138 .
Left Front TPMS Initiator	Behind left side of front bumper. See Fig. 173 .
Left Rear TPMS Initiator	On left rear fenderwell. See Fig. 183 .
Left Search Coil	On rear differential. See Fig. 188 .
Left Side Curtain Airbag Inflator Connector	In left "C" pillar. See Fig. 146 .
Low Horn	Behind middle of front bumper. See Fig. 171 .
MES Connector	Under left side of dash. See Fig. 58 .
Millimeter Wave Radar (2006)	Behind front grille. See Fig. 171 .
Navigation Service Check Connector	Under navigation unit. See Fig. 159 .
Noise Reduction Condenser Connector	In right "C" pillar. See Fig. 145.
Rear Accessory Power Socket	Rear of center console. See Fig. 72 .
Rear Bumper LF Antenna Connector	Behind middle of rear bumper. See Fig. 168 .

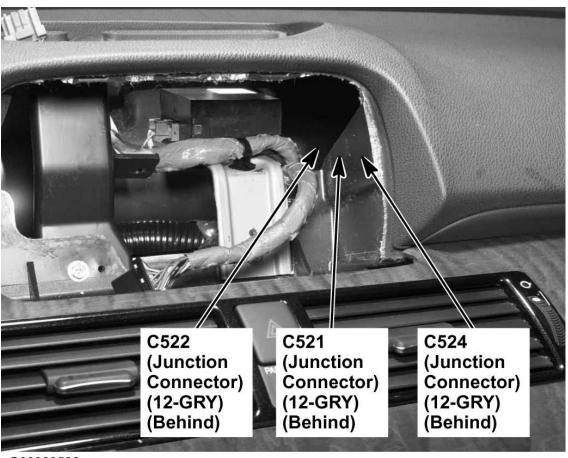
<u>Fig. 73: Behind Middle Of Dash</u> Courtesy of AMERICAN HONDA MOTOR CO., INC.

Junction Connector C516	Behind middle of dash. See Fig. 73.
Junction Connector C517	Behind middle of dash. See Fig. 73.
Junction Connector C518	Behind middle of dash. See Fig. 76.
Junction Connector C519	Behind middle of dash. See Fig. 76.
Junction Connector C520	Under center console. See Fig. 86 .
Junction Connector C521	Behind middle of dash. See Fig. 74 .
Junction Connector C522	Behind middle of dash. See Fig. 74 .
Junction Connector C523	Behind middle of dash. See Fig. 79.
Junction Connector C524	Behind middle of dash. See Fig. 74 .
Junction Connector C525	Under right side of dash. See Fig. 96.
Junction Connector C526	Under right side of dash. See Fig. 96.
Junction Connector C607	Behind left kick panel. See Fig. 63.
Junction Connector C608	Behind left kick panel. See Fig. 62.
Junction Connector C609	Behind left kick panel. See Fig. 62.
Junction Connector C610	Under driver's seat. See Fig. 108 .
Junction Connector C612	In left "C" pillar. See Fig. 148.

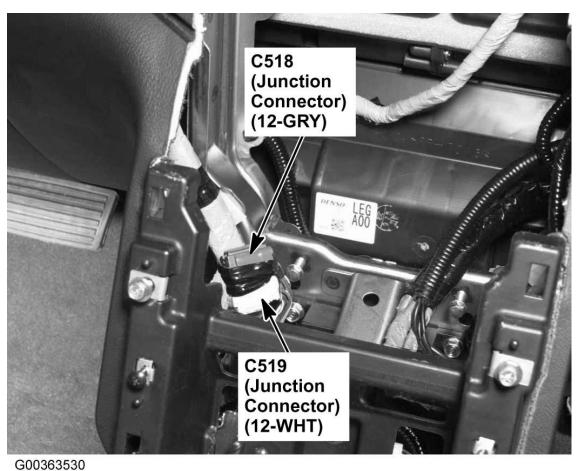
Fig. 75: Behind Middle Of Dash Courtesy of AMERICAN HONDA MOTOR CO., INC.

Keyless Access RF Unit 1	Behind middle of dash. See Fig. 75 .
Keyless Access RF Unit 2	Middle of rear shelf. See Fig. 161 .
Main Antenna Module	In right "C" pillar. See Fig. 142 .
Moonroof Control Unit	Rear of roof. See Fig. 141.
Navigation Unit	In trunk, below left side of package tray. See <u>Fig.</u> <u>158</u> .
OnStar Control Unit	Behind rear seat. See Fig. 151 .
OPDS Unit	In front passenger's seat back. See Fig. 110 .
PCM	Under middle of dash. See Fig. 82.
Power Rear Window Sunshade Control Unit	Middle of rear shelf. See Fig. 160.
Power Seat Control Unit	Under driver's seat. See <u>Fig. 106</u> .

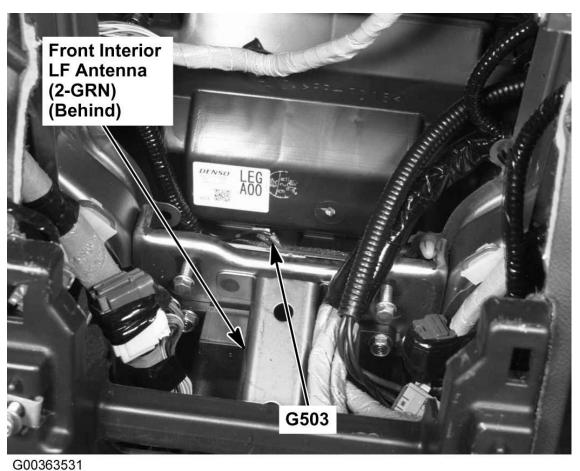
Fig. 76: Behind Middle Of Dash Courtesy of AMERICAN HONDA MOTOR CO., INC.

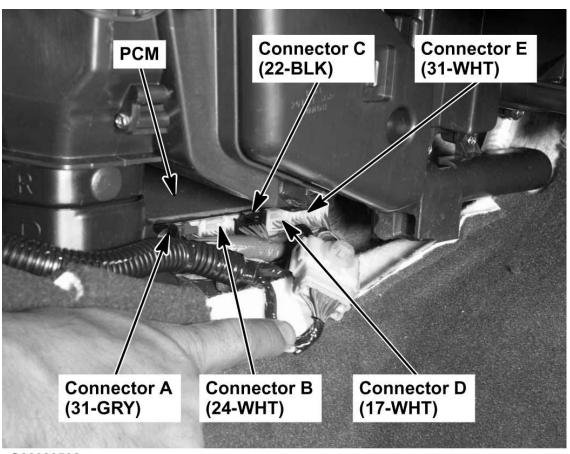
Fig. 81: Under Middle Of Dash Courtesy of AMERICAN HONDA MOTOR CO., INC.

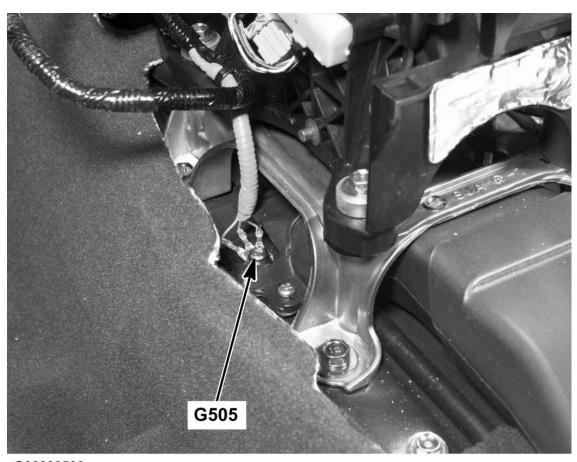
Fig. 84: Under Center Console Courtesy of AMERICAN HONDA MOTOR CO., INC.

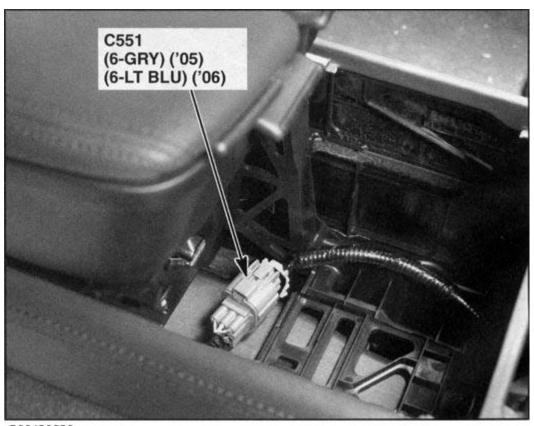
Fig. 86: Under Center Console Courtesy of AMERICAN HONDA MOTOR CO., INC.

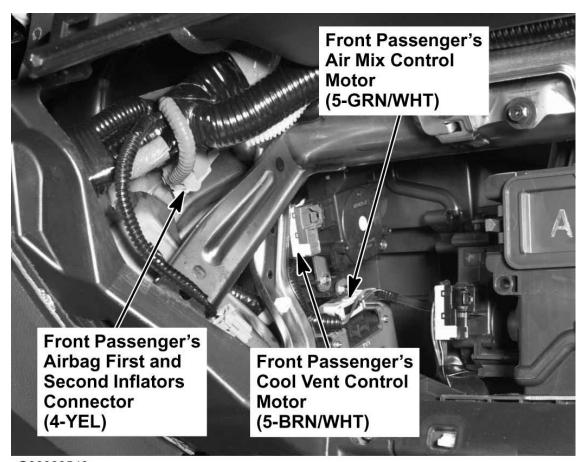
Fig. 88: Under Center Console Courtesy of AMERICAN HONDA MOTOR CO., INC.

Rear Interior LF Antenna	Under rear of center console. See Fig. 88 .
Rear Shelf LF Antenna	Middle of rear shelf. See Fig. 162 .
Right Front TPMS Initiator	Behind right side of front bumper. See Fig. 173 .
Right Rear TPMS Initiator	On right rear fenderwell. See Fig. 183 .
Right Search Coil	On rear differential. See Fig. 185 .
Right Side Curtain Airbag Inflator Connector	In right "C" pillar. See Fig. 143.
TPMS Receiver Unit	Right side of rear shelf. See Fig. 163 .
T1	In under-hood fuse/relay box. See Fig. 32 .
Т3	Left rear of engine, near starter solenoid. See <u>Fig.</u> <u>23</u> .
T10 (Terminal Joint)	Top left side of engine. See Fig. 21.
T11 (Terminal Joint)	Right side of engine compartment. See Fig. 3 .
T12 (Terminal Joint)	Top left side of engine. See Fig. 21 .
T15	On rear differential. See Fig. 186 .
T16	Behind left side rear seat headrest. See Fig. 117 .
T17	Behind center rear seat headrest. See Fig. 117.

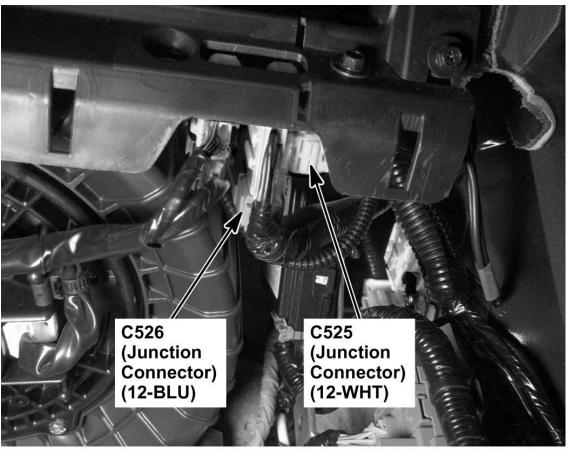
Fig. 95: Under Right Side Of Dash Courtesy of AMERICAN HONDA MOTOR CO., INC.

C771 (White, 20 Pin)	Under right side of dash. See <u>Fig. 95</u> .
C772 (Light Blue, 6 Pin)	Behind right kick panel. See Fig. 99 .
C773 (White, 20 Pin)	In front passenger's door. See Fig. 129 .
C774 (White, 20 Pin)	Front of front passenger's door. See Fig. 128 .
C781 (White, 18 Pin)	Left "B" pillar. See Fig. 127 .
C782 (White, 6 Pin)	In left rear door. See <u>Fig. 136</u> .
C791 (Gray, 17 Pin)	Right "B" pillar. See Fig. 127 .
C792 (White, 6 Pin)	In right rear door. See Fig. 136 .
C801 (Gray, 4 Pin)	Under front passenger's seat. See Fig. 113 .
C831 (White, 12 Pin)	Middle of trunk. See Fig. 167 .
C851 (White, 8 Pin)	Rear of roof. See Fig. 141 .
C901 (White, 23 Pin)	Under driver's seat. See <u>Fig. 105</u> .

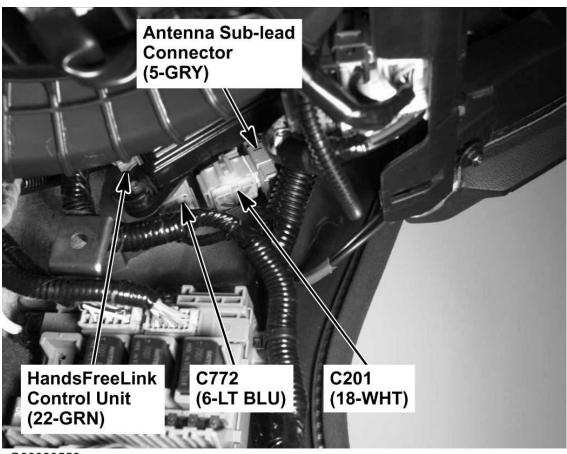
Fig. 98: Behind Right Kick Panel Courtesy of AMERICAN HONDA MOTOR CO., INC.

C633 (White, 6 Pin)	In right "C" pillar. See Fig. 144 .
C651 (White, 34 Pin)	Behind right kick panel. See Fig. 98 .
C652 (White, 8 Pin)	Behind right kick panel. See Fig. 98 .
C653 (White, 23 Pin)	Behind rear seat. See Fig. 152 .
C654 (White, 12 Pin)	Behind rear seat. See Fig. 152.
C655 (Yellow, 16 Pin)	Behind rear seat. See Fig. 152 .
C656 (White, 20 Pin)	In right "C" pillar. See Fig. 144 .
C657 (White, 12 Pin)	Right side of trunk. See Fig. 166 .
C658 (White, 12 Pin)	Behind rear seat. See Fig. 153 .
C659 (White, 8 Pin)	Behind rear seat. See Fig. 153 .
C698 (Gray, 10 Pin)	Near rear differential. See Fig. 185 .
C699 (Gray, 6 Pin)	Near rear differential. See Fig. 185 .
C701 (White, 20 Pin)	Left side of trunk. See <u>Fig. 155</u> .
C751 (White, 14 Pin)	Under left side of dash. See <u>Fig. 57</u> .
C752 (White, 20 Pin)	Front of driver's door. See Fig. 128 .
C754 (White, 28 Pin)	In driver's door. See Fig. 129 .

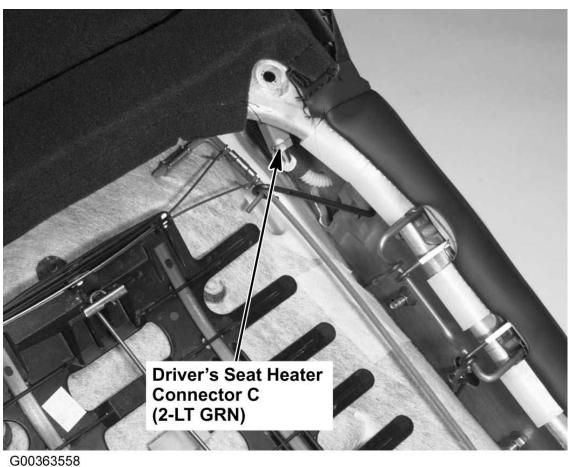
Fig. 103: Right Side Of Driver's Seat Courtesy of AMERICAN HONDA MOTOR CO., INC.

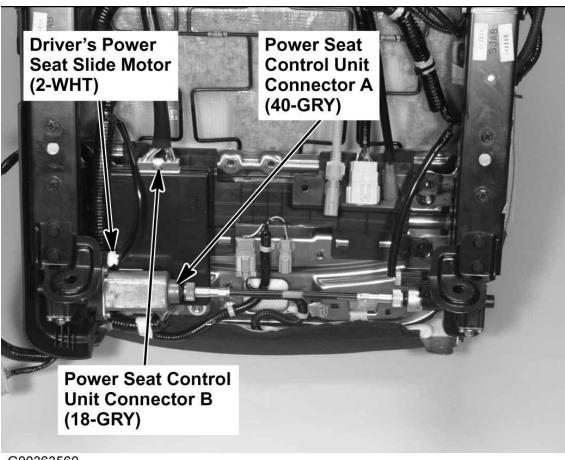
Fig. 105: Under Driver's Seat **Courtesy of AMERICAN HONDA MOTOR CO., INC.**

C903 (Gray, 2 Pin)	Under driver's seat. See Fig. 105 .
C951 (Gray, 3 Pin)	Under rear seat. See Fig. 120.
C961 (Gray, 3 Pin)	Right side of rear seat. See Fig. 118.
C962 (Gray, 3 Pin)	Behind center of rear seat. See Fig. 119.
C963 (Gray, 3 Pin)	Behind center of rear seat. See Fig. 119.
C971 (Gray, 19 Pin)	Under driver's seat. See Fig. 109 .
C981 (Gray, 6 Pin)	Under front passenger's seat. See Fig. 116 .
C991 (2006) (White, 12 Pin)	Under middle of dash. See Fig. 200.
C992 (2006) (White, 5 Pin)	Behind right kick panel. See Fig. 202.
C993 (2006) (White, 2 Pin)	Behind right kick panel. See Fig. 202.

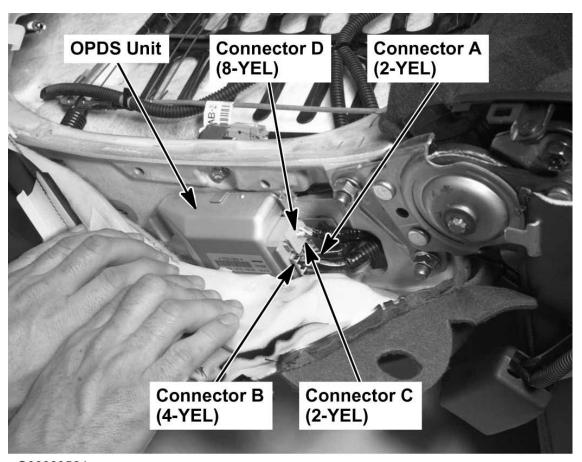
Fig. 109: Under Driver's Seat Courtesy of AMERICAN HONDA MOTOR CO., INC.

Sensor Connector	Ŭ
Driver's Power Seat Slide Position Sensor	Under driver's seat. See Fig. 107.
Driver's Seat Position Sensor	Under front of driver's seat. See Fig. 109.
Driver's Vent Air Temperature Sensor	Behind left side of gauge control module. See Fig. 51 .
ECT Sensor 1	On top left side of engine. See Fig. 20 .
ECT Sensor 2	Left side of engine. See Fig. 18 .
EGR Valve Position Sensor	Left side of engine. See Fig. 20 .
Evaporator Temperature Sensor Connector	Under left side of dash. See Fig. 68.
Front A/F Sensor (B2, S1) Connector	Middle of engine. See Fig. 16 .
Front Passenger's Door Outer Handle Light/Touch Sensor Connector	Center of front passenger's door. See Fig. 133.
Front Passenger's Power Seat Recline Motor/Position Sensor Connector	Under front passenger's seat. See Fig. 111.
Front Passenger's Vent Air Temperature Sensor	Under right side of dash. See Fig. 90 .
Front Secondary HO2S (B2, S2) Connector	Middle of engine. See Fig. 16.

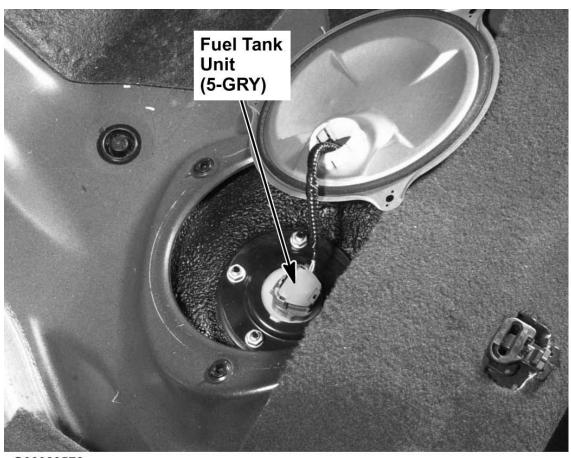
Fig. 121: Left Side Of Floor (Right Similar) Courtesy of AMERICAN HONDA MOTOR CO., INC.

G604	In left "C" pillar. See <u>Fig. 146</u> .
G651	At right side of floor. See Fig. 121 .
G652	In right "C" pillar. See Fig. 147 .
G653 (2006)	Behind right kick panel. See Fig. 202.
G701	Left side of trunk. See <u>Fig. 155</u> .
G851	In right "C" pillar. See Fig. 143 .

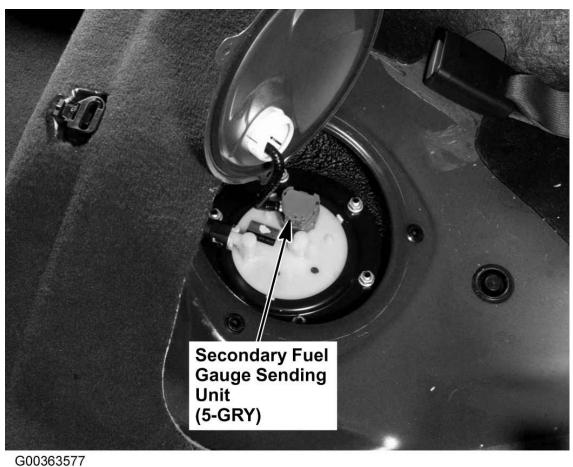
Fig. 122: Under Rear Seat Courtesy of AMERICAN HONDA MOTOR CO., INC.

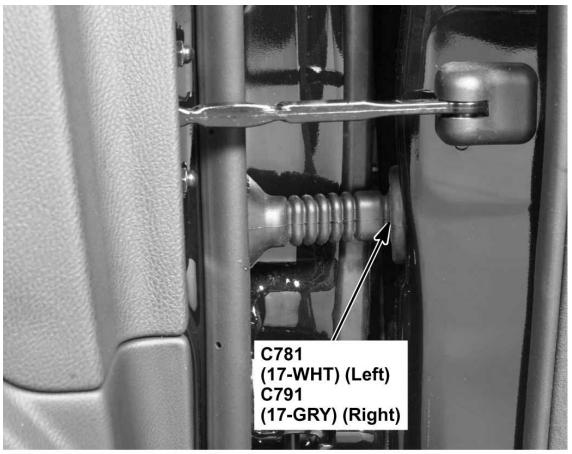
Fig. 126: Left "B" Pillar (Right Similar)
Courtesy of AMERICAN HONDA MOTOR CO., INC.

Junction Connector C613	In left "C" pillar. See Fig. 148.
Junction Connector C615	In left "C" pillar. See Fig. 149 .
Junction Connector C616	In left "C" pillar. See Fig. 149.
Junction Connector C660	At base of right "B" pillar. See Fig. 126 .
Junction Connector C661	At base of left "B" pillar. See Fig. 126 .
Junction Connector C662	Behind rear seat. See Fig. 153 .
Junction Connector C663	Behind rear seat. See Fig. 153 .
Junction Connector C702	On left side of trunk. See Fig. 155 .
Junction Connector C755	In driver's door. See Fig. 134 .
Junction Connector C756	In driver's door. See Fig. 134 .
Junction Connector C757	In driver's door. See Fig. 130 .
Junction Connector C775	In front passenger's door. See Fig. 130 .
Junction Connector C776	In front passenger's door. See Fig. 135.
Junction Connector C783	In left rear door. See Fig. 131 .
Junction Connector C793	In right rear door. See Fig. 131 .
Junction Connector C833	Middle of trunk. See Fig. 167 .

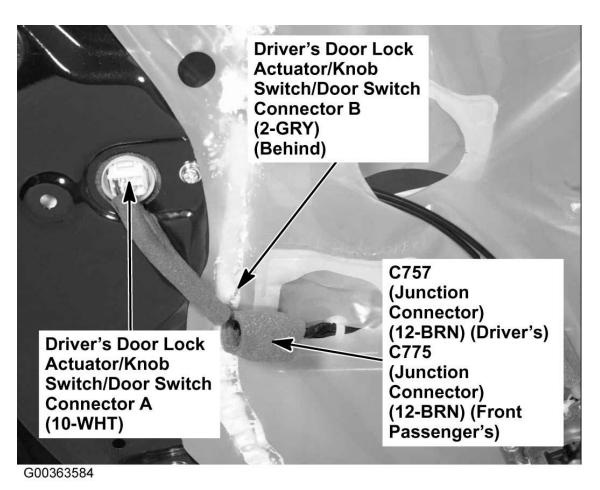
Fig. 129: Driver's Door (Front Passenger's Similar) Courtesy of AMERICAN HONDA MOTOR CO., INC.

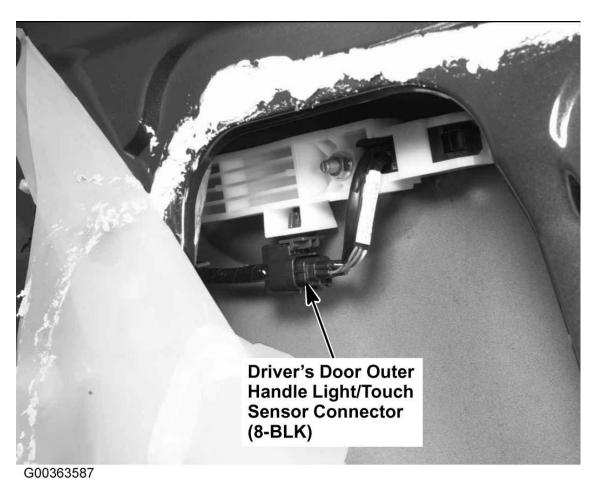
Fig. 132: Driver's Door (Front Passenger's Similar) Courtesy of AMERICAN HONDA MOTOR CO., INC.

Component	Location
Blower Motor	Under right side of dash. See Fig. 94.
Center/Left/Right Rear Headrest Actuator	Behind respective rear seat headrest. See Fig. 117.
Driver's Air Mix Control Motor	Below left side of dash. See Fig. 69.
Driver's Cool Vent Control Motor	Under left side of dash. See Fig. 68.
Driver's Lumbar Support Motor Connector	Under right side of driver's seat. See Fig. 103 .
Driver's Power Seat Slide Motor	Under driver's seat. See Fig. 106 .
Driver's Power Window Motor	Center of driver's door. See Fig. 132.
Front Passenger's Air Mix Control Motor	Behind right side of dash. See Fig. 89.
Front Passenger's Cool Vent Control Motor	Behind right side of dash. See Fig. 89.
Front Passenger's Lumbar Support Motor Connector	Under front passenger's seat. See Fig. 111 .
Front Passenger's Power Seat Slide Motor	Under front passenger's seat. See Fig. 114 .
Front Passenger's Power Window Motor	Center of front passenger's door. See Fig. 132 .

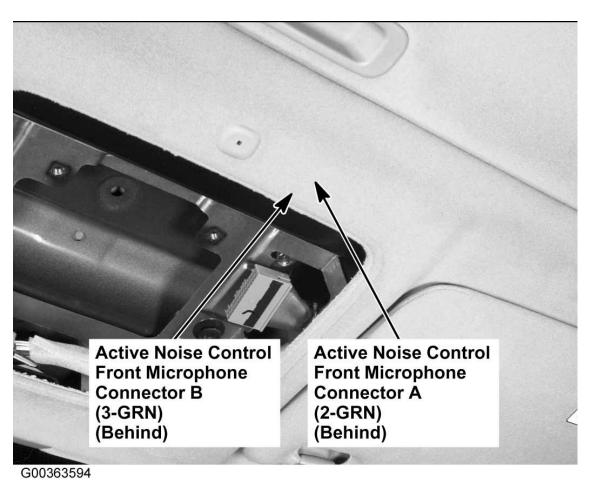
Fig. 138: Left Front Of Roof Courtesy of AMERICAN HONDA MOTOR CO., INC.

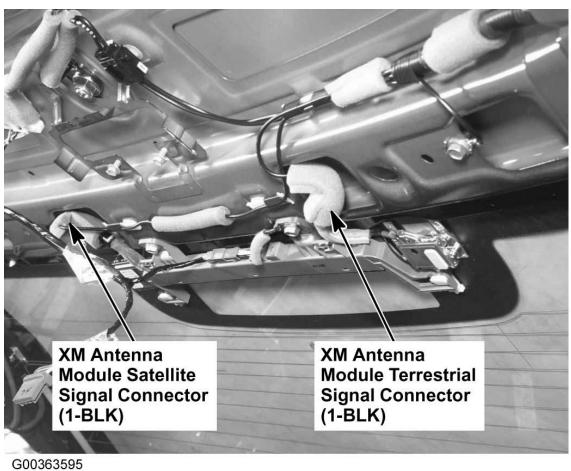
Fig. 139: Front Of Roof Courtesy of AMERICAN HONDA MOTOR CO., INC.

Component	Location
Active Noise Control Front Microphone	In center front of roof. See Fig. 139.
AcuraLink (USA)	Left side of trunk. See Fig. 156.
Alternator	Right front of engine compartment. See Fig. 4.
AM Signal Main Window Antenna	Right "C" pillar. See Fig. 142.
Antenna Sub-Lead Connector	Behind right kick panel. See Fig. 99 .
Audio Amplifier	Right side of trunk. See Fig. 164.
Blower Power Transistor	Behind right side of dash, left of blower motor. See Fig. 93 .
Cable Real Connector A	On steering column. See Fig. 48.
Cable Reel Connector B	On steering column. See Fig. 47.
Cable Reel Connector C	On steering wheel. See Fig. 45 .

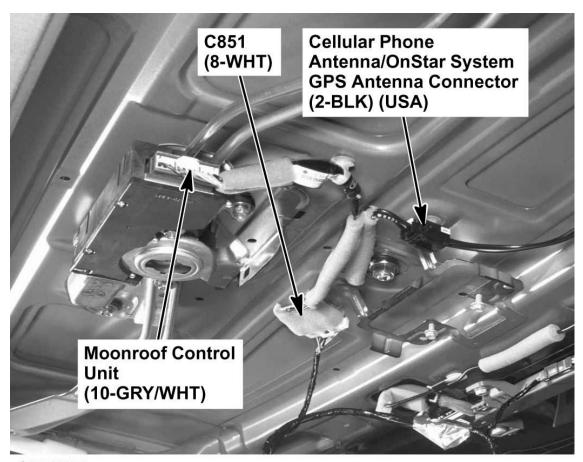
Fig. 140: Rear Of Roof (USA)
Courtesy of AMERICAN HONDA MOTOR CO., INC.

T18	Behind right side rear seat headrest. See Fig. 117 .
T101	In under-hood fuse/relay box. See Fig. 32 .
T102	Right side of engine compartment. See <u>Fig. 5</u> .
XM Antenna Satellite Signal Connector	Center rear of roof. See Fig. 140 .
XM Antenna Terrestrial Signal Connector	Center rear of roof. See Fig. 140.

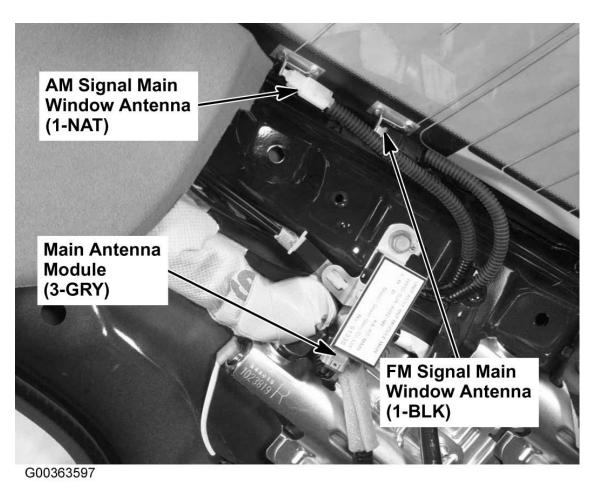
Fig. 141: Rear Of Roof Courtesy of AMERICAN HONDA MOTOR CO., INC.

Cellular Phone Antenna/OnStar System GPS Antenna Connector	Rear of roof. See Fig. 141.
Data Link Connector (DLC)	Under left side of dash. See Fig. 52.
Driver's Airbag First & Second Inflators Connector	In base of steering column. See Fig. 44.
Driver's Seat Belt Tensioner Connector	At base of left "B" pillar. See Fig. 126.
Driver's Seat Heater Connector	Under driver's seat. See Fig. 104 .
Driver's Side Airbag Inflator Connector	Under driver's seat. See Fig. 105 .
FM Signal Main Window Antenna	Right "C" pillar. See Fig. 142 .
FM Signal Sub-Window Antenna	In left "C" pillar. See Fig. 146 .
Front Interior LF Antenna	Behind middle of dash. See Fig. 77.
Front Passenger's Airbag First & Second Inflators Connector	Behind glove box. See Fig. 89 .
Front Passenger's Seat Belt Tensioner Connector	At base of right "B" pillar. See Fig. 126.
Front Passenger's Seat Heater Connector	Under front passenger's seat. See Fig. 114 .

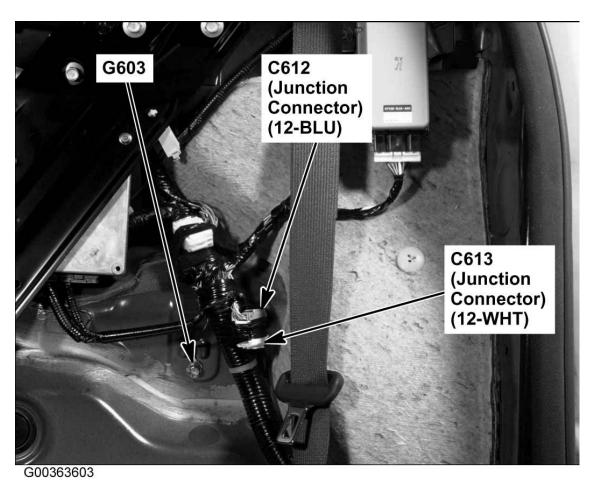
Fig. 147: Left "C" Pillar (Right Similar)
Courtesy of AMERICAN HONDA MOTOR CO., INC.

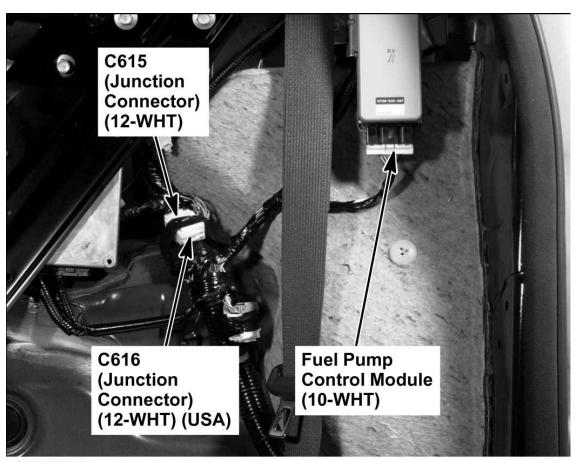
Fig. 148: Left "C" Pillar Courtesy of AMERICAN HONDA MOTOR CO., INC.

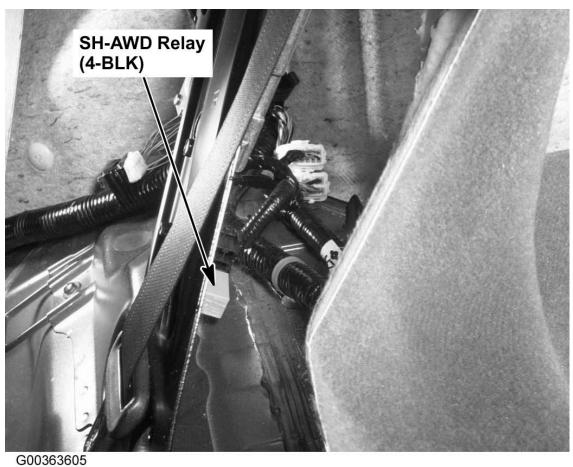
Fig. 149: Left "C" Pillar Courtesy of AMERICAN HONDA MOTOR CO., INC.

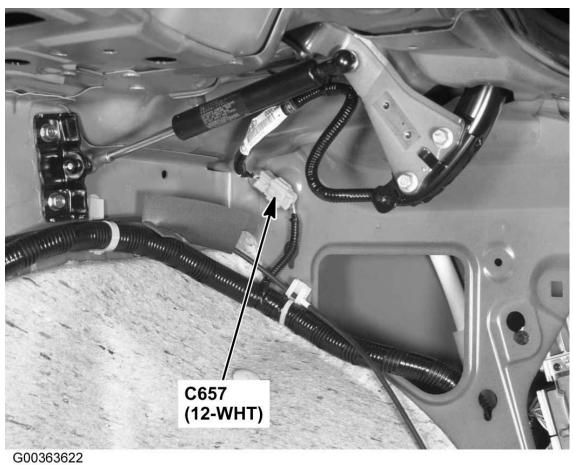
Fig. 165: Right Side Of Trunk Courtesy of AMERICAN HONDA MOTOR CO., INC.

Component	Location
ACC Control Unit (2006)	Behind right side of dash. See Fig. 201.
Active Noise Control Unit	Right side of trunk. See Fig. 165 .
AcuraLink Control Unit (XM Receiver)	On left side of trunk. See Fig. 157.
Adaptive Front Lighting Control Unit	Under left side of dash. See Fig. 66 .
Driver's MPCS Unit	In driver's door. See Fig. 134.
DRL Control Unit	Under left side of dash. See Fig. 67 .
ECPS Control Unit	Under left side of dash. See Fig. 66 .
E-Tensioner Unit (2006)	Under middle of dash. See Fig. 199.
Front Passenger's MPCS Unit	In front passenger's door. See Fig. 135 .
Fuel Pump Control Module	In left "C" pillar. See Fig. 149 .
Hands FreeLink Control Unit	Behind right kick panel. See Fig. 99 .
Immobilizer Control Unit-Receiver	On right side of steering column. See Fig. 49 .
Imoes Unit	Under right side of dash. See Fig. 90.
Keyless Access Control Unit	Under left side of dash. See Fig. 60 .

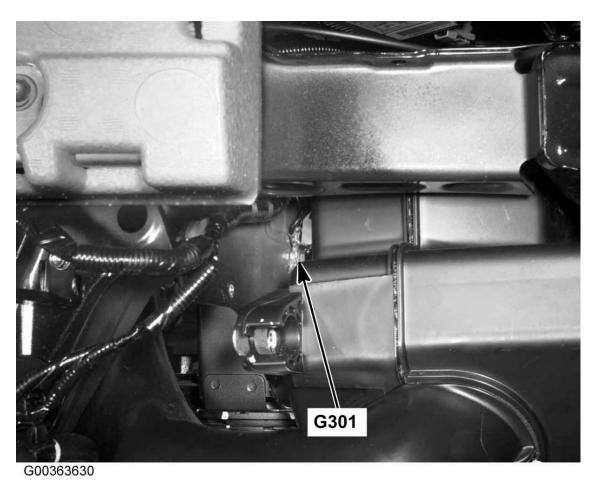
Fig. 173: Behind Left Side Of Front Bumper (Right Similar) Courtesy of AMERICAN HONDA MOTOR CO., INC.

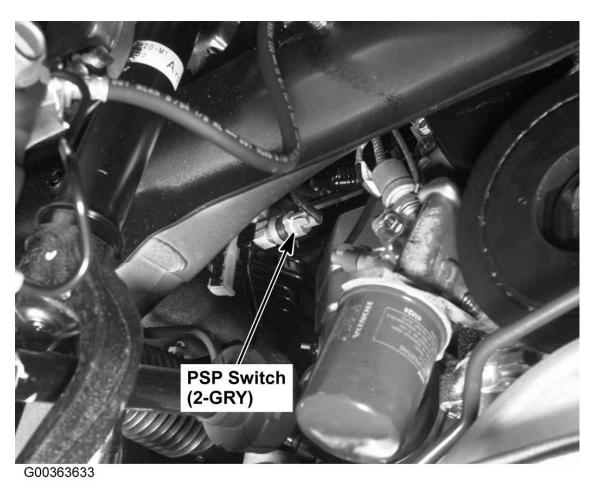
Fig. 176: Right Side Of Engine Courtesy of AMERICAN HONDA MOTOR CO., INC.

Injector No. 5	Middle of engine. See Fig. 13 .
Injector No. 6	Middle of engine. See Fig. 13.
Left Clutch Electromagnetic Coil	On rear differential. See Fig. 187 .
Right Clutch Electromagnetic Coil	On rear differential. See Fig. 189 .
Shift Lock Solenoid	Under center console. See Fig. 84.
Shift Solenoid Valve	On rear differential. See Fig. 188 .
Starter Solenoid	On starter. See Fig. 23.
VTEC Solenoid Valve Connector	Right side of engine. See Fig. 176.

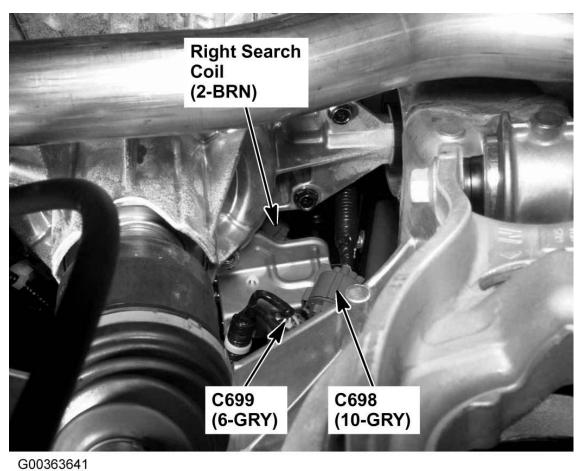
Fig. 184: Under Left Rear Of Vehicle Courtesy of AMERICAN HONDA MOTOR CO., INC.

FTP Sensor	Above rear differential. See Fig. 190 .
Headlight Leveling Sensor	Under left rear of vehicle. See Fig. 184.
Hypoid Gear Speed Sensor	On rear differential. See Fig. 186.
IAT Sensor	Left side of engine. See Fig. 20 .
In-Car Temperature Sensor	On dash, right of steering column. See Fig. 39.
Input Shaft (Mainshaft) Speed Sensor	In transmission housing. See Fig. 25.
Knock Sensor	On top middle of engine, below intake manifold. See Fig. 14 .
Left Front Impact Sensor	Behind left side of front bumper. See Fig. 173 .
Left Front Pressure Sensor	Left side of engine compartment. See Fig. 197 .
Left Front Wheel Speed Sensor Connector	Left side of engine compartment. See Fig. 36.
Left Rear Wheel Speed Sensor Connector	Under left rear of vehicle. See Fig. 184 .
Left Side Impact Sensor	At base of left "B" pillar. See Fig. 125.
Left Side Impact Sensor (2nd)	In left "C" pillar. See Fig. 147.
Lett blue Impact belisti (2114)	in ich C pillat. See <u>Fig. 147</u> .

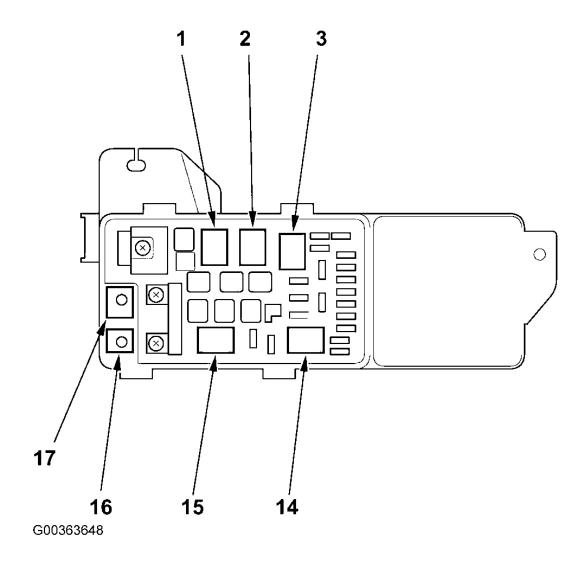
Fig. 190: Above Rear Differential Courtesy of AMERICAN HONDA MOTOR CO., INC.

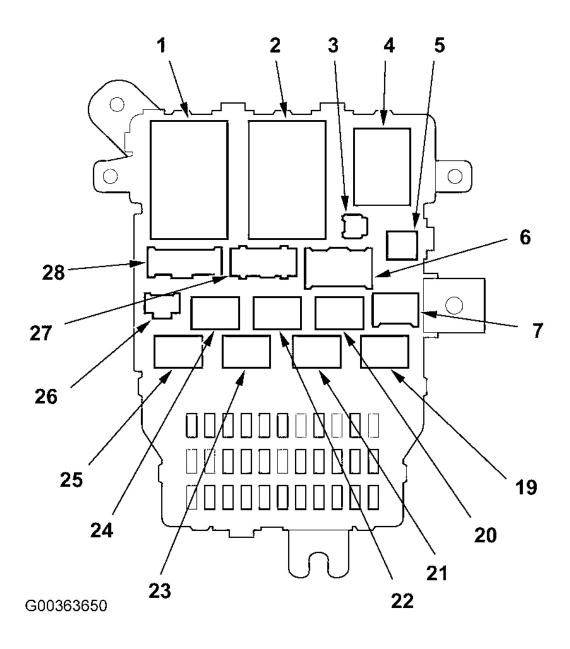
Fig. 192: Left Rear Of Engine Compartment Courtesy of AMERICAN HONDA MOTOR CO., INC.

Ref	Socket	Cavities	Connects to
1	DRL Relay (Canada)	5	Engine Compartment Wire Harness A (Left Branch)
2	Radiator Fan Control (RFC) Unit Relay	4	Engine Compartment Wire Harness A (Left Branch)
3	Adaptive Cruise Control Relay ('06: Technology Package)	5	Engine Compartment Wire Harness A (Left Branch)

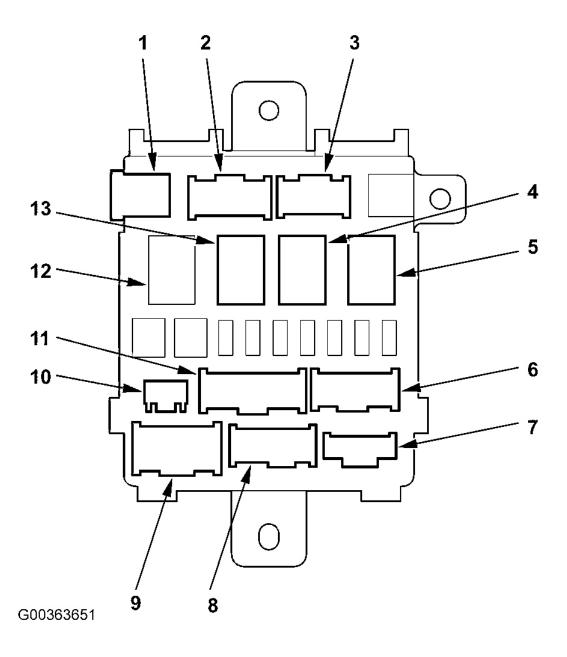
Fig. 193: Behind Left Kick Panel Courtesy of AMERICAN HONDA MOTOR CO., INC.

Component	Location
Accessory Power Socket Relay (20)	In driver's under-dash fuse/relay box. See Fig. 193 .
A/C Compressor Clutch Relay (2)	In under-hood fuse/relay box. See Fig. 191 .
ACC Relay (2)	In auxiliary under-dash relay box. See Fig. 196.
A/F Sensor Relay (21)	In driver's under-dash fuse/relay box. See <u>Fig.</u> <u>193</u> .
Blower Motor Relay (1)	In under-hood fuse/relay box. See Fig. 191 .
DRL Relay (1)	In auxiliary under-hood relay box. See Fig. 192 .
Fog Light Relay (14)	In under-hood fuse/relay box. See Fig. 191 .
Fuel Fill Door Opener Relay (5)	In passenger's under-dash fuse/relay box. See Fig. 194 .
HVAC Control Motor Relay	Behind right side of dash. See Fig. 92.
Ignition Coil Relay (24)	In driver's under-dash fuse/relay box. See Fig. 193 .
IG2 Relay (1)	In auxiliary under-dash relay box. See Fig. 196 .
Keyless Answer Back Buzzer	Behind middle of rear bumper. See Fig. 168 .
Optional Relay (12)	In passenger's under-dash fuse/relay box. See Fig. 194 .

PGM-FI Main Relay 1 (22)	In driver's under-dash fuse/relay box. See Fig. 193 .
PGM-FI Main Relay 2 (25)	In driver's under-dash fuse/relay box. See <u>Fig.</u> 193.
Radiator Fan Control (RFC) Unit Relay (2)	In auxiliary under-hood relay box. See Fig. 192.
Rear Window Defogger Relay (3)	In under-hood fuse/relay box. See Fig. 191 .
Seat Heater Relay (4)	In passenger's under-dash fuse/relay box. See <u>Fig.</u> 194.
SH-AWD Relay	Behind rear seat. See Fig. 150.
Starter Cut Relay 1 (1) (2005)	In auxiliary under-dash relay holder. See Fig. 195 .
Starter Cut Relay 1 (1) (2006)	In auxiliary under-dash relay holder. See <u>Fig.</u> 203.
Starter Cut Relay 2 (19)	In driver's under-dash fuse/relay box. See <u>Fig.</u> 193.
Throttle Actuator Control Module Relay (13)	In passenger's under-dash fuse/relay box. See <u>Fig.</u> 194.
Turn Signal/Hazard Relay 2 (Sounder)	Under left side of dash. See Fig. 43.
Turn Signal/Hazard Relay (4)	In driver's under-dash fuse/relay box. See <u>Fig.</u> <u>193</u> .

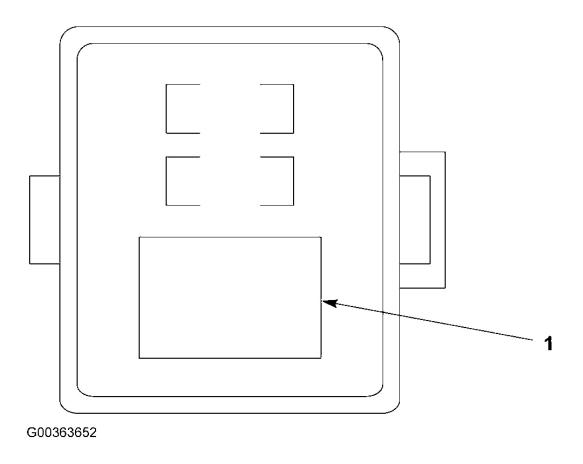
Fig. 194: Behind Right Kick Panel Courtesy of AMERICAN HONDA MOTOR CO., INC.
