Front Compartment Upper Side Rail Replacement

Removal Procedure

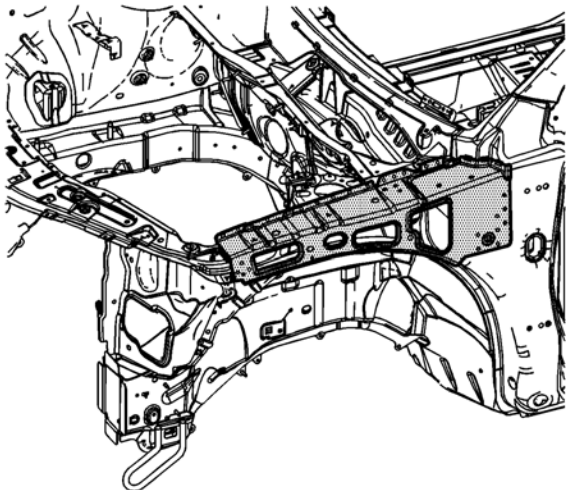
1. Disable the supplemental inflatable restraint (SIR) system. Refer to [SIR Disabling and Enabling](#) .
2. Disconnect the negative battery cable. Refer to [Battery Negative Cable Disconnection and Connection](#) .
3. Remove all related panels and components.
4. Repair as much of the damage as possible to factory specifications. Refer to [Dimensions - Body](#) .
5. Note the location and remove the sealers and anti-corrosion materials from the repair area, as necessary. Refer to [Anti-Corrosion Treatment and Repair](#) .

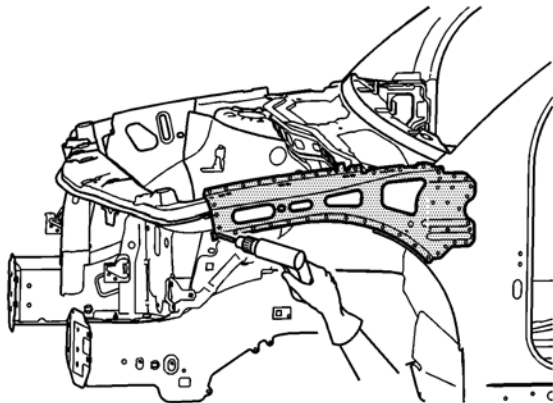
Important: Do not damage any inner panels or reinforcements.

6. Locate and drill out all factory welds. Note the number and location of the welds for installation of the front upper outer rail.

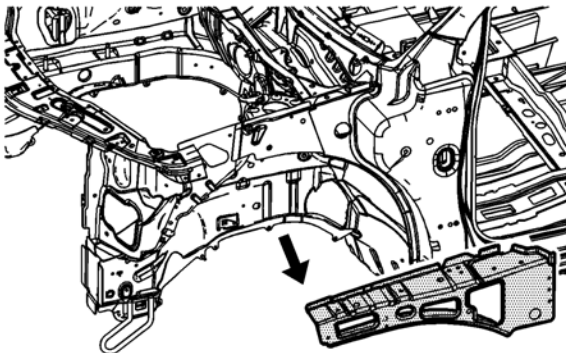
7. Remove the damaged front upper outer rail.
