# Headlining Trim Panel Replacement (C105/Short Body)

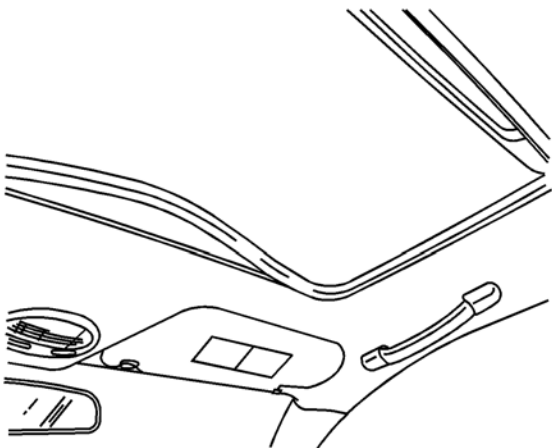
1. Disconnect the negative battery cable. Refer to [Battery Negative Cable Disconnection and Connection](#) .
2. Remove the sunroof molding, if equipped.
3. Remove the passenger assist handles. Refer to [Assist Handle Replacement](#) .
4. Remove the dome lamp. Refer to [Dome Lamp Replacement](#) .
5. Remove the sun visors. Refer to [Sunshade Replacement](#) .
6. Remove the power sunroof control switch, if equipped. Refer to [Sunroof Switch Replacement](#) .
7. Remove the windshield garnish molding. Refer to [Windshield Garnish Molding Replacement](#) .
8. Remove the center pillar upper garnish molding. Refer to [Center Pillar Upper Garnish Molding Replacement](#) .
9. Remove the quarter window garnish molding. Refer to [Body Side Window Rear Garnish Molding Replacement](#) .

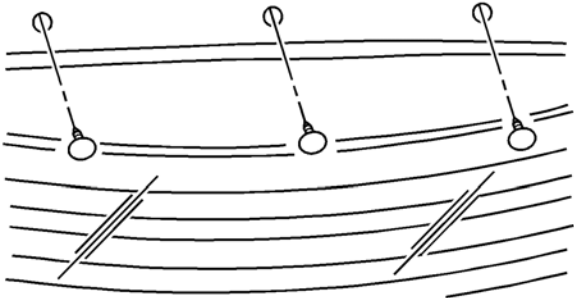
10. Remove the plastic retainers in the headliner.
11. Recline both front seats.
12. Remove the headliner through a rear door.

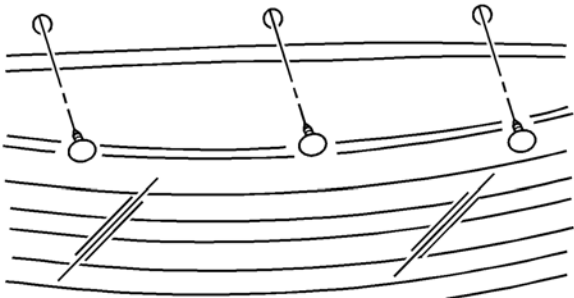
1. Recline both front seats.
