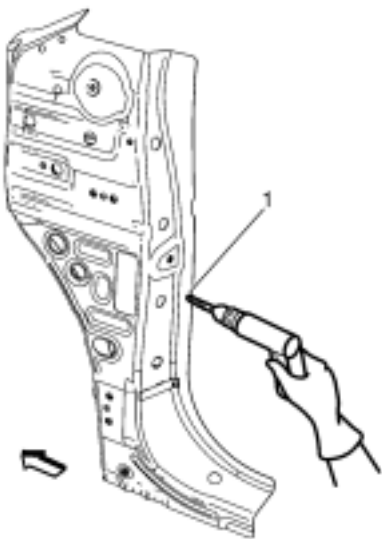
- 3. Drill **8 mm (5/16 in)**holes for plug welding along the edges of the front hinge pillar body as noted from the original panel (1).
- 4. Clean and prepare the attaching surfaces for welding.
