Turn Signal Multifunction Switch Replacement

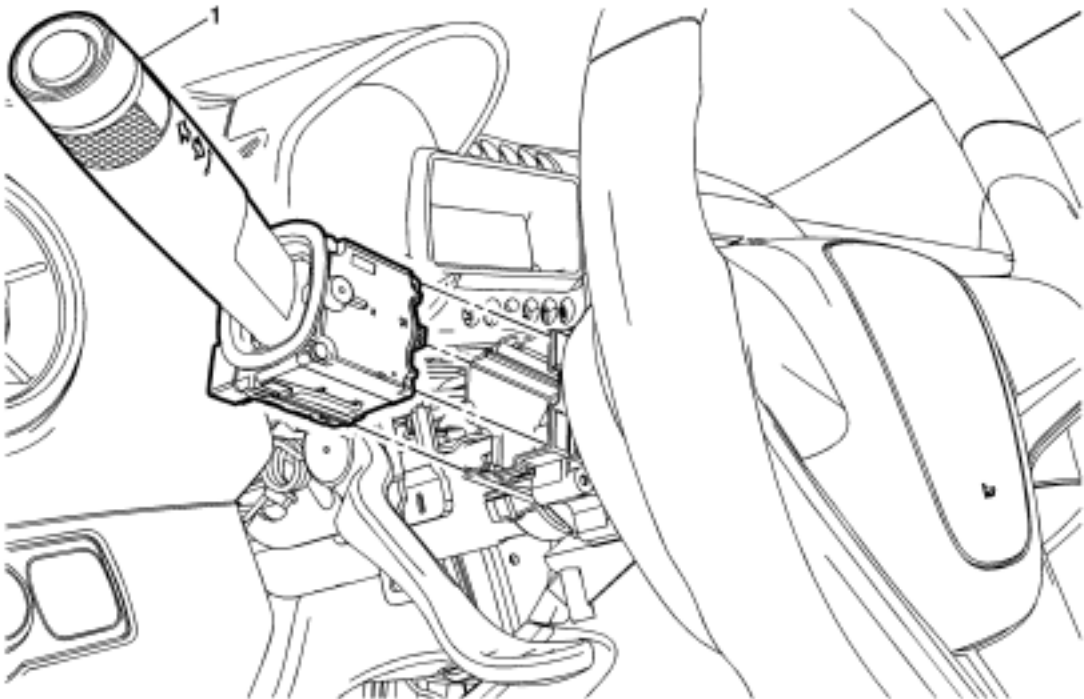
Callout	Component Name
<p>Preliminary Procedure</p> <p>Remove the upper trim cover and the lower trim cover from the steering column. Refer to Steering Column Lower Trim Cover Replacement .</p>	
1	<p>Turn Signal Switch</p> <p>Procedure</p> <ol style="list-style-type: none">1. Disconnect any electrical connectors as necessary.2. Release the plastic retaining tabs and remove the turn signal multifunction switch from the turn signal switch bracket.
