## Front End Upper Tie Bar Replacement

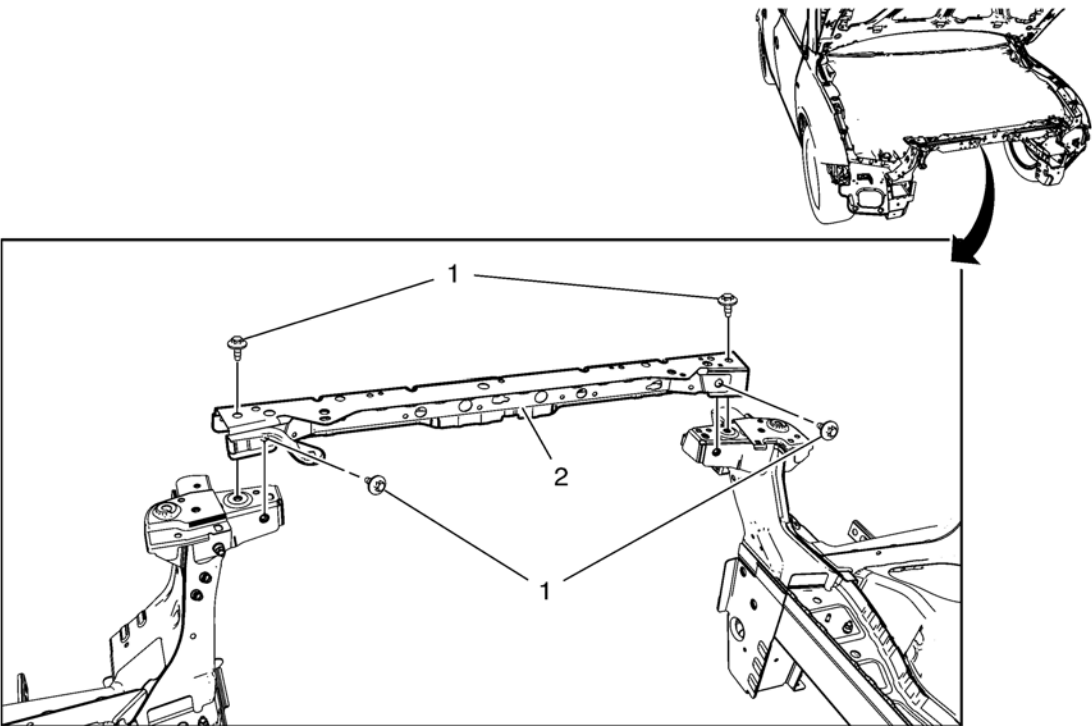
| Callout | Component Name |
|---|--|
| <p><b>Preliminary Procedure</b></p> <ol style="list-style-type: none"><li>1. Remove the front bumper fascia. Refer to <a href="#">Front Bumper Fascia Replacement</a></li><li>2. Remove the radiator support bracket. Refer to <a href="#">Radiator Support Bracket Replacement</a></li><li>3. Remove the radiator grille reinforcement support. Refer to <a href="#">Radiator Grille Reinforcement Support Replacement</a></li><li>4. Remove the hood primary and secondary latch. Refer to <a href="#">Hood Primary and Secondary Latch Replacement</a></li></ol> | |
| 1 | Headlamp and Front Bumper Fascia Mount Panel Bolt (Qty: 4)<br><b>Caution:</b> Refer to <a href="#">Fastener Caution</a> in the Preface section.<br><b>Tighten</b><br>22 N·m (17 lb ft) |
| 2 | Front End Upper Tie Bar |
