Rear Bumper Impact Bar Stud Plate Replacement (MIG-Brazing)

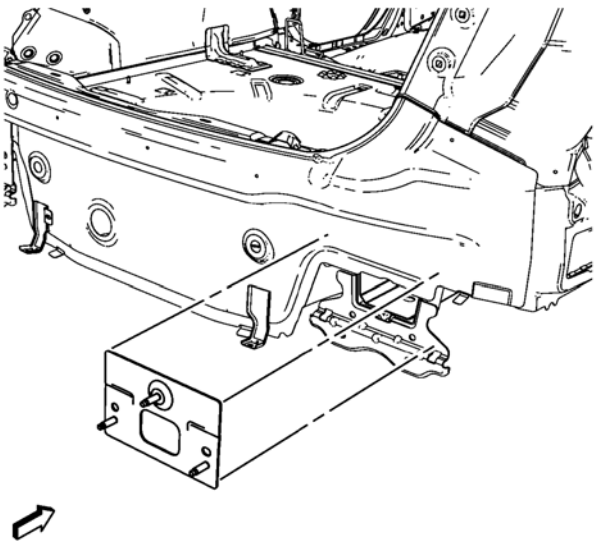
1. Clean and prepare the attaching surfaces for brazing.
2. Apply structural adhesive to the attaching surfaces.
